Nomad

ALERT SERVICE BULLETIN

EXHAUST - NOZZLE HALF CLAMP INSPECTION/MODIFICATION

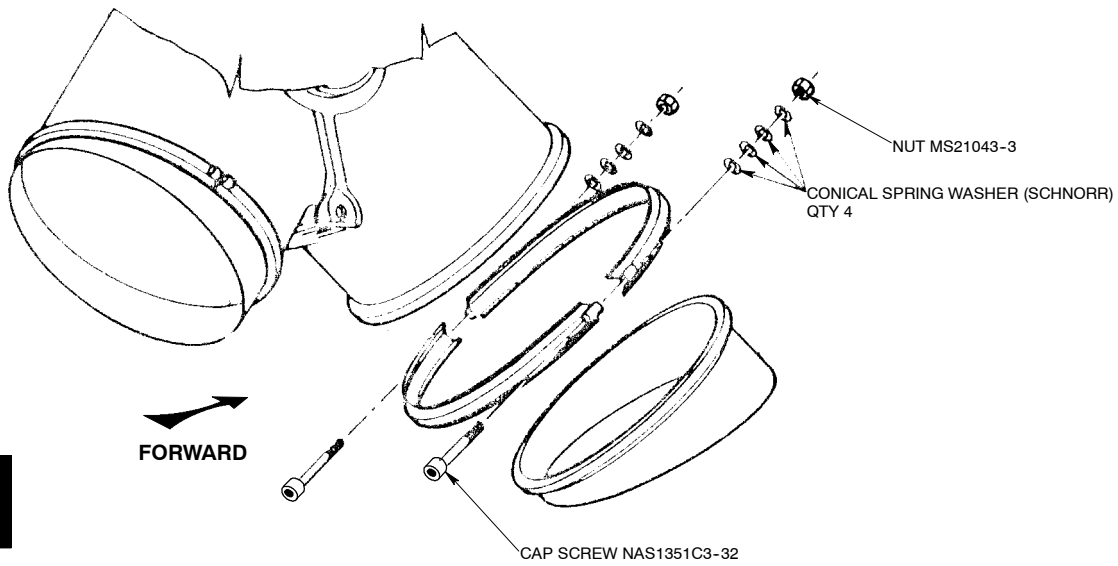
Figure 1 Exhaust Nozzle Clamp Installation

(1) Several half-clamp failures have occurred due to one or more of the following: overtightening of the clamp bolts; misalignment of the clamp ends; or stress concentrations arising from grinding marks and interference of fasteners in the clamp.

- (1) Open lower cowl.
- (2) Refer to Fig 1 and remove the exhaust stub nozzle half-clamps and stub nozzles from the engine.
- (3) Discard existing bolts, nuts and plain washers, retain conical spring washers.

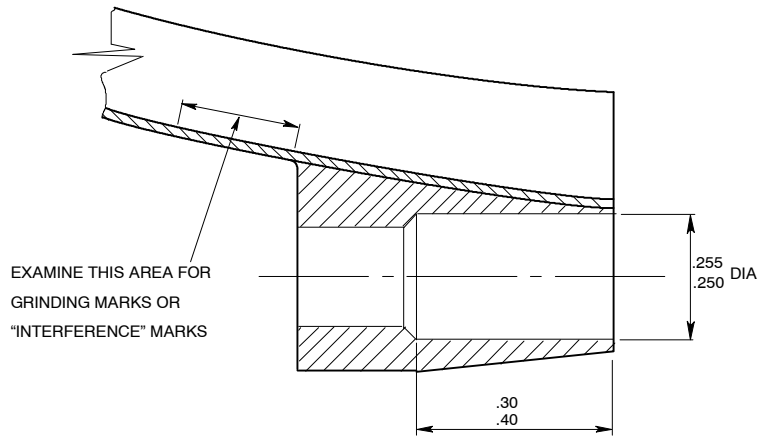
Figure 2 Clamp and Rework

- (4) Dye penetrant inspect each half-clamp PN 1/N-50-548 in the vicinity of the welds for evidence of cracking. Any cracking is cause for rejection. Examine welds and the area shown on Fig 2 for evidence of grinding and/or "interference" marks. Any grinding marks which result in a loss of clamp thickness are a cause for rejection, other marks may be dressed using a round needle file to remove burrs and sharp corners.

- (b) Insert a clamp bolt through each bolt hole. Bolts should pass through the bolt hole without interference.
 - (c) If the bolt will not pass through the bolt hole and there is obvious distortion of the half-clamp ends, reject the half-clamp/s. If the bolt will not pass through the bolthole and there is NO obvious distortion of the half-clamp ends, turn a half-clamp 180° and re-check. If it will still not pass through, counterbore the half-clamp ends per Fig 2 and re-check.
Reject if the bolt will still not pass through.
