SERVICE BULLETIN

SUBJECT: FLIGHT CONTROL TRIM INDICATOR SYSTEMS (MOD N493)

S/B NMD-27-18
Page 1 of 7

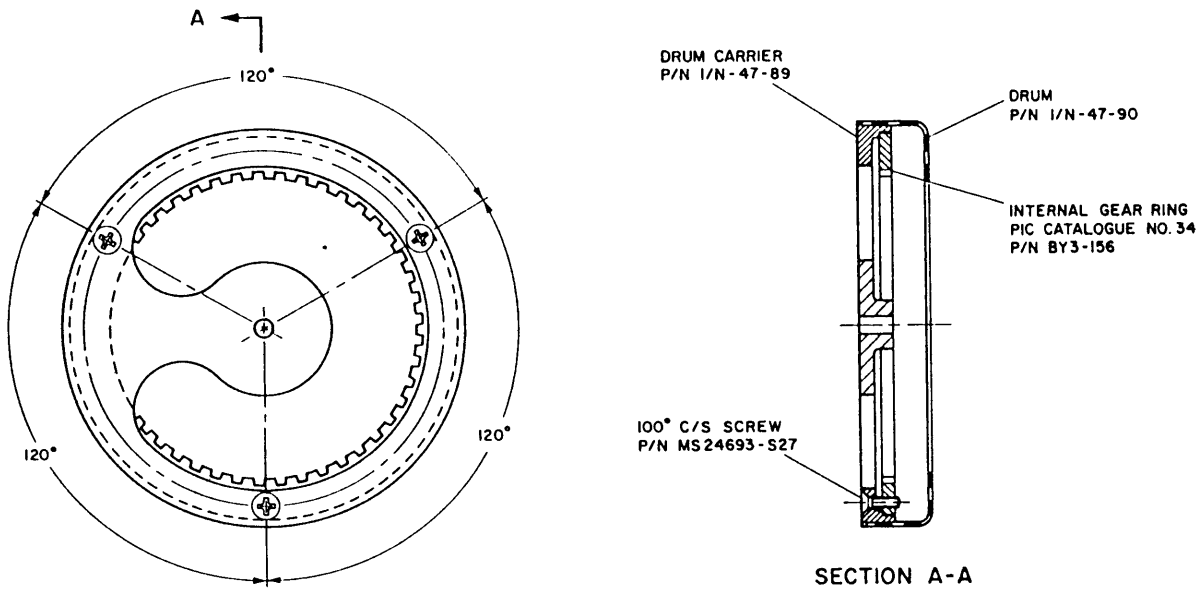
Rework of Trim Indicator Drum Assemblies
Figure 1

- (1) An instance has occurred in which the internal gear ring became detached from the drum carrier of the horizontal stabiliser trim indicator drum assembly, due to unsatisfactory adhesive bonding. This could cause trim tab angles outside the allowable range to be obtained as well as incorrect trim to be selected.
- (2) The same hazard could occur to the rudder trim indicator drum assembly.
- (3) Instances have also been reported of the failure of the taper pin attaching the spur gear to the trunnion shaft (Ref Figure 2 and IPC 27-40-01 Figure 1 items 9, 10 and 7).

- F. Inspect the indicator drum assembly to ensure that the internal gear ring is correctly seated in the drum carrier (Ref Figure 1). If it is not correctly seated, press the gear ring back into the carrier drum until correctly seated taking care not to damage the drum or gear ring.

- G. Using a No.32 drill (0.1160 inches diameter, 2.95 mm), drill three holes equally spaced on a 1.875 inches pitch circle radius through the drum carrier and gear ring.

- H. Enlarge the three holes in the drum carrier only, to 0.142 inches diameter (3.6 mm) and countersink the enlarged holes 100 degrees and 0.280 inches diameter.
- J. Tap the three holes in the internal gear ring to 6-32 UNC and secure the gear ring to the drum carrier with three MS 24693-S27 screws or suitable alternative, using loctite AV or equivalent.

- (1) DRILL 3 HOLES (USING NO. 32 DRILL) EQUALLY SPACED AT 1.875 INCH PITCH CIRCLE RADIUS THROUGH DRUM CARRIER AND INTERNAL GEAR RING.
- (2) HOLES DIAMETER TO BE INCREASED TO 0.142 INCH (3.6 MM) IN DRUM CARRIER ONLY THEN COUNTERSINK ENLARGED HOLES 100° TO 0.280 INCH DIA.
- (3) TAP HOLES IN INTERNAL GEAR RING TO 6-32 UNF AND SECURE DRUM CARRIER TO GEAR RING AS DETAILED IN TEXT (REF PARA 2 H)
