# SERVICE BULLETIN

## INCORRECT ASSEMBLY OF INBOARD BRAKE PUSH ROD UPPER BOLT

**NMD-27-32**

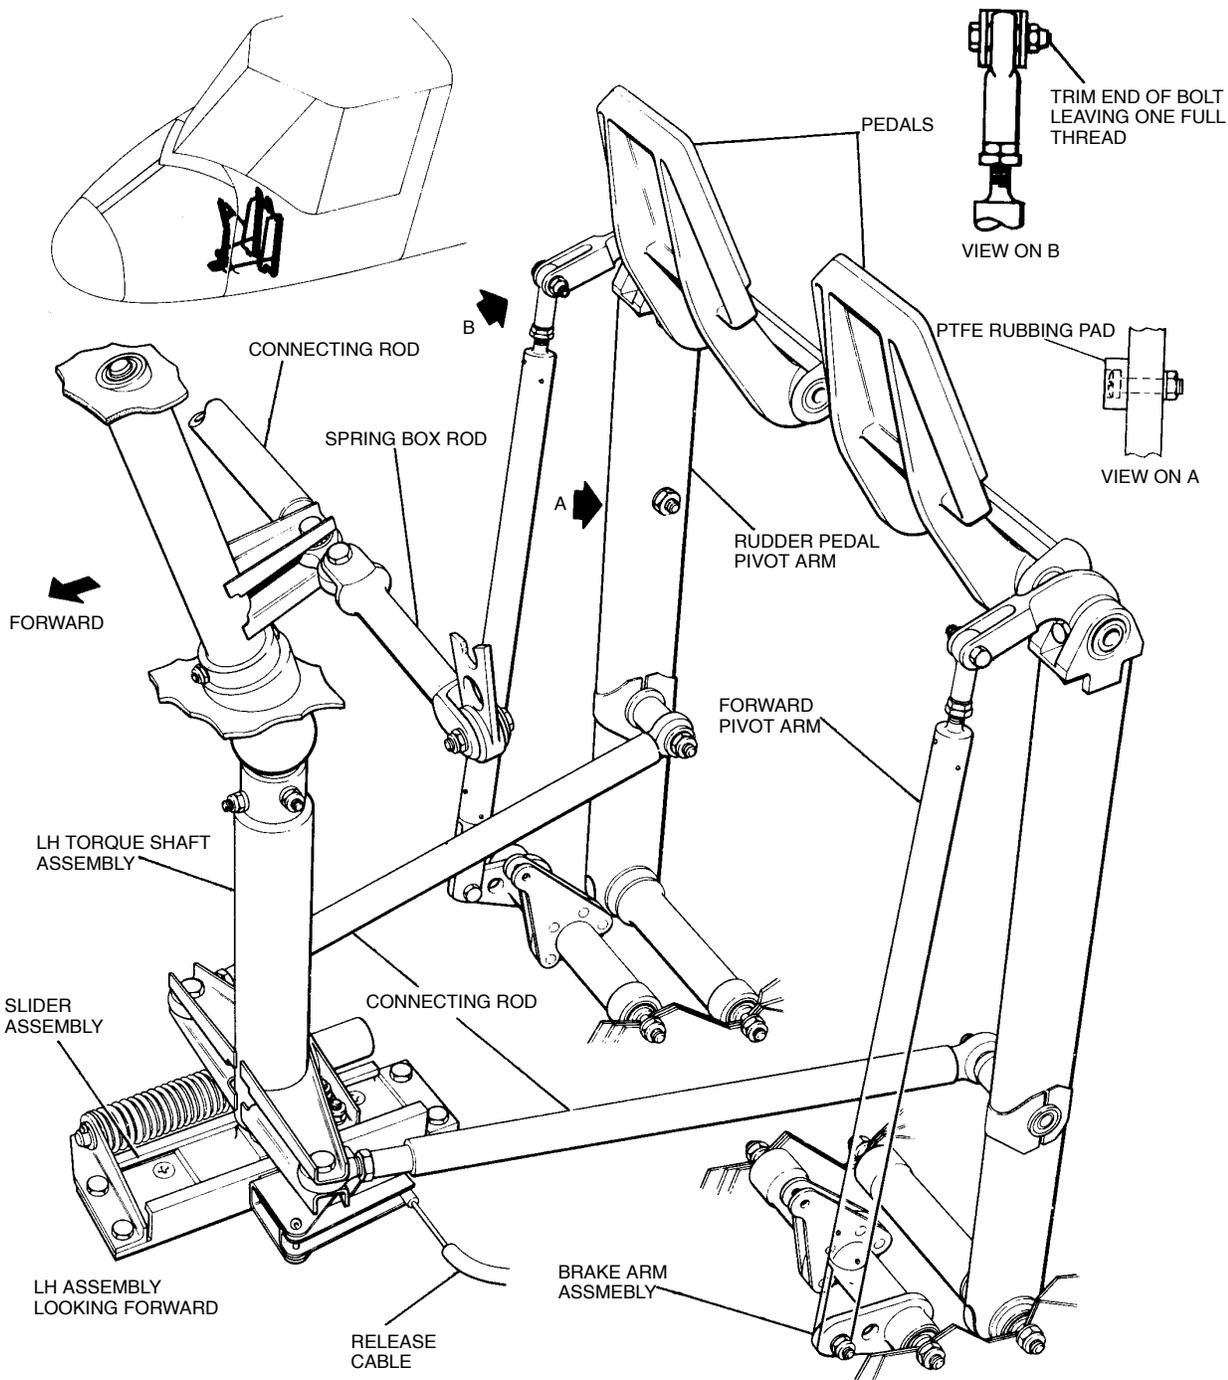
**Figure 1 Rudder Pedal Pivot Arm and Control Rods**

Instances have occurred in which the bolt attaching the brake push rods to the rudder pedal levers have been incorrectly assembled and have been able to foul the brake system hydraulic pipes which pass over the nosewheel well. Fouling only occurs when the rudder pedals are operated in the fully forward adjusted position.

- (1) Remove the upper inboard rudder pedal guards (Ref IPC Chap 53–20–02 Page Figure 1 items 11 and -12).
- (2) Inspect the bolts attaching the brake operating push rod to the rudder pedal lever (Ref IPC Chap 27–20–02 Figure 2 Item 26) for correct installation. The bolt head should be facing away from the pedal side of the lever (Ref Figure 1) .

- (3) Bolts fitted incorrectly are to be removed and refitted with the bolt heads furthest away from the associated rudder pedal, as shown in IPC Chap 27–20–02 Page 0 Figure 2. Torque tighten the nut to between 20 and 25 lb in.

- (7) Ensure that both the pilot's RH rudder pedal and co-pilot's LH pedal assemblies are inspected as detailed in steps (1) to (6) inclusive.
- (8) Refit the upper inboard rudder pedal guards then check that the correctly installed bolts (attaching the brake operating push rod to the rudder pedal lever) do not foul the ends of the slots in the rudder pedal guards. (Ref IPC Chap 53-20-02 Page 0 Figure 1 items 11 and -12). Trim the ends of the bolts (if not already done), back until only one full thread protrudes through the nut (See view on B in Figure 1).

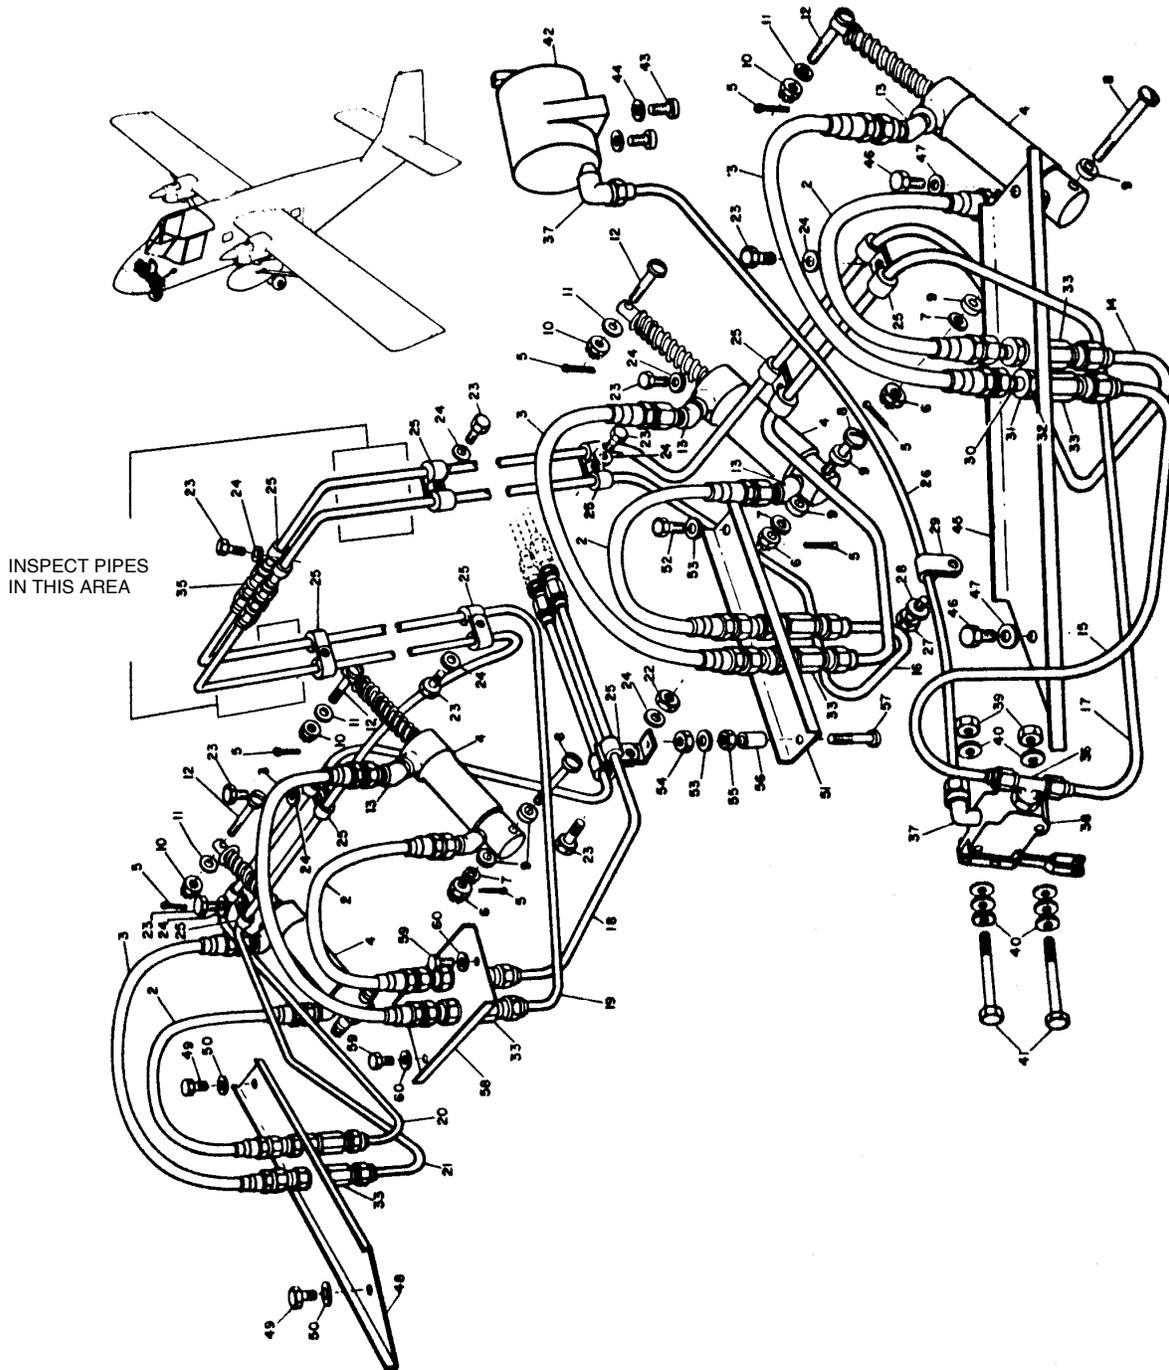
Figure 2 Braking System Stn 64.00 to Stn 91.13

- (4) Inspect the brake hydraulic pipes which pass over the forward end of the nosewheel well (Ref Figure 2) for damage caused by either incorrect fitment of the push rod bolt or by incorrect positioning of the pipes. Damage to the pipes may be rub marks or gouges. If the pipes are badly marked they should be replaced (Ref IPC Chap 32–40–00 Page 1 Figure 2 items 14, 16, 19 and 21). Light scratches may be blended out and a conversion coating (Alodine) applied.

- (5) Ensure that the pipes are correctly positioned as close to the nosewheel well wall and as far forward as possible but without obstructing the transverse control rod assembly (Ref IPC Chap 27–20–02 Figure 5 item -1A) which connects the pilot's and co-pilot's rudder torque shafts.
