# **Nomad**

# SERVICE BULLETIN

## **FLIGHT CONTROLS – RUDDER PEDAL PIVOT ARMS – INSPECTION AND REPAIR (MOD N794)**

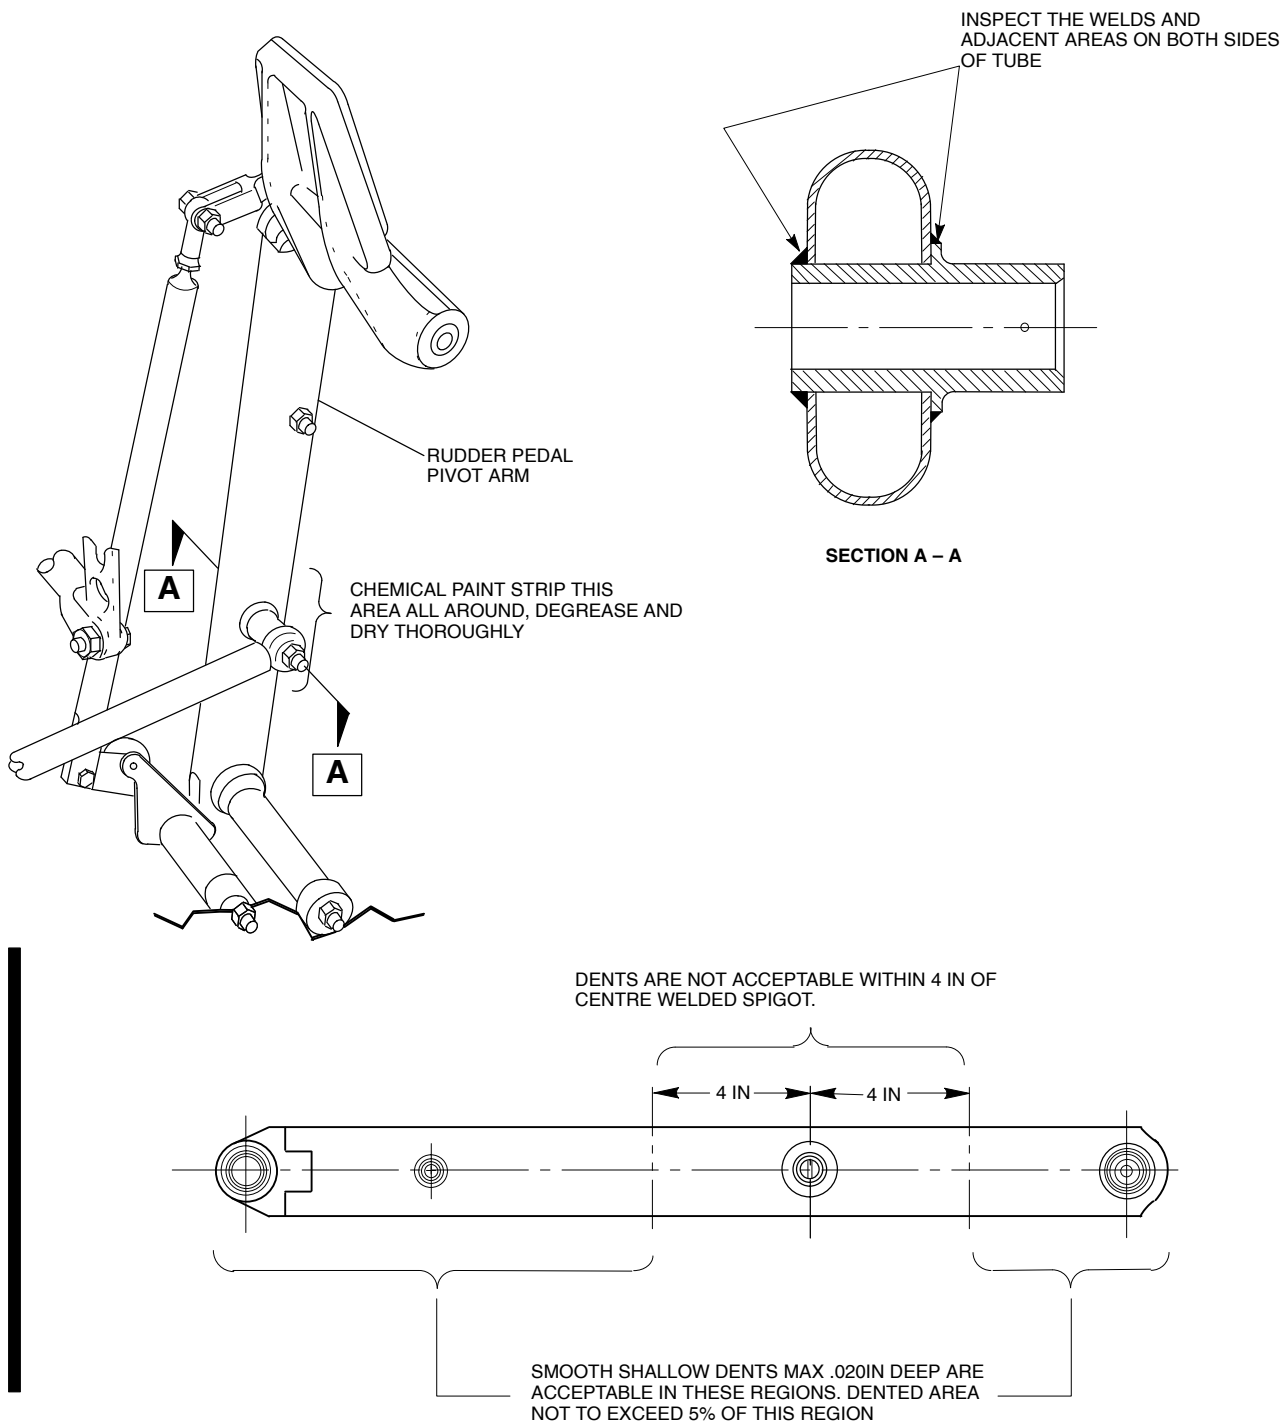
**Figure 1 Rudder Pedal Pivot Arm Inspection Area**

(1) Cracks have been reported in several Pivot Arm Sub-assemblies PN 2/N-45-965 at the junction of the Angled Pivot Arm PN 1/N-45-974. Evidence of corrosion has been found to exist inside the pivot arm tube.

- (b) Chemically strip paint from the area around the central spigot of the rudder pedal pivot arms, degrease and dry thoroughly (Ref Fig 1).
- (c) Fluorescent dye penetrant inspect the area around the shaft housing (Ref Fig 1) for evidence of cracking in, or adjacent to, the welds. Any cracking is cause for rejection.
- (d) Reprotect bare metal using Zinc Chromate Primer.
- (e) Inspect (using x10 magnification and boosted light) all areas of tubing including all welding at upper and lower ends of the pivot arms. Inspect for dents and cracks (Ref Fig 1). Any cracking is cause for rejection.

Dents are NOT acceptable within 4 inches of centre welded spigot. Smooth shallow dents max. 0.020 inch deep are acceptable outside the 8 inch region. Dented area not to exceed 5% of this region (Ref Fig 1).

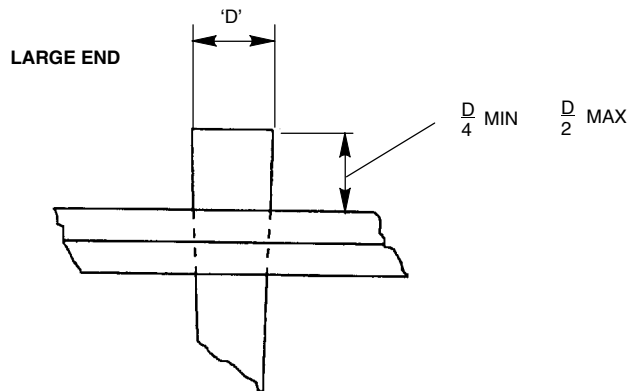
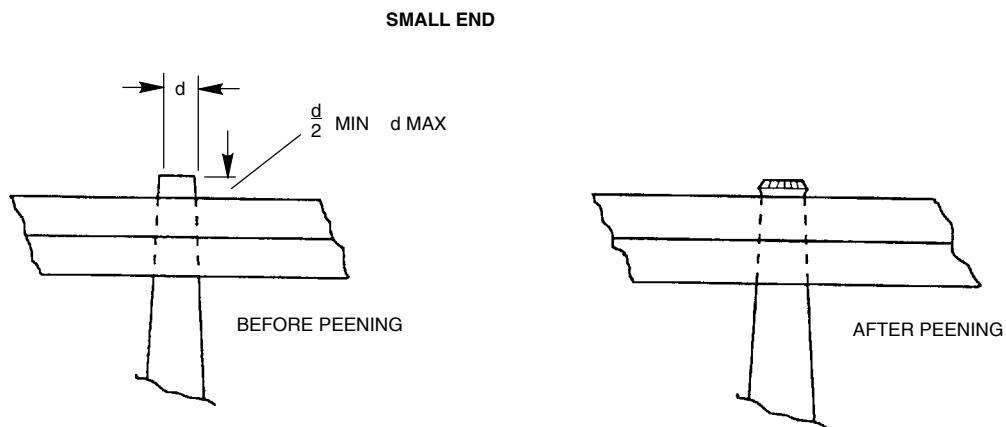
Figure 4 Retaining of Solid Taper Pins

NOTE:  
DEFORMATION IS PERMISSIBLE ON LARGE  
END (MAY OCCUR DUE TO EFFECT OF THE  
ANVIL)

- (a) Small end to protrude between 1/2 to 1 diameter (Ref Fig 4).
- (b) Large end to protrude between 1/4 to 1/2 diameter (Ref Fig 4).

(20) Peen small end of taper pin to form as shown in Fig 4.
