SERVICE BULLETIN NO.: NMD-53-8

DATED: 25th October, 1989

Fuselage, Enlarged Access Panel for Oleo Charging Valve in Pods

(Mod N547).

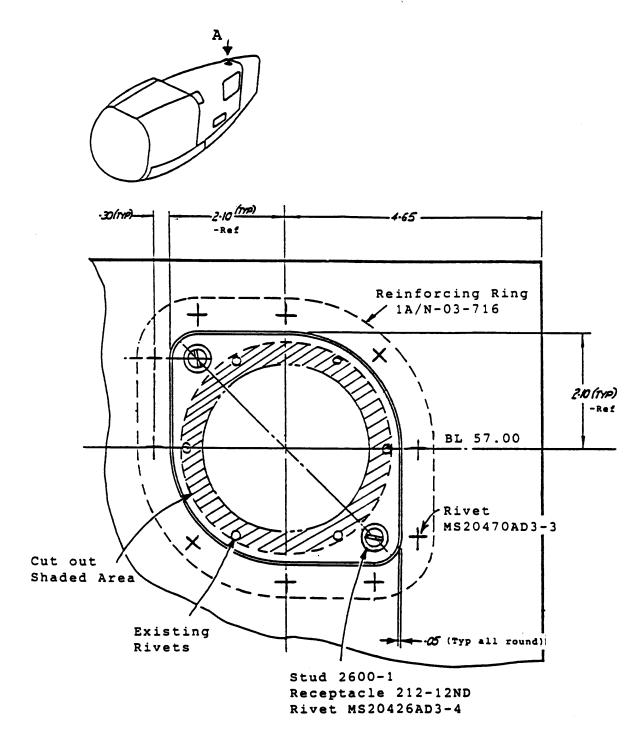
Installation of Cover Assembly Figure 1

View on Arrow A - LH Pod (RH Opposite)

The existing access cover on the top rear of the pod is replaced by a larger cover.

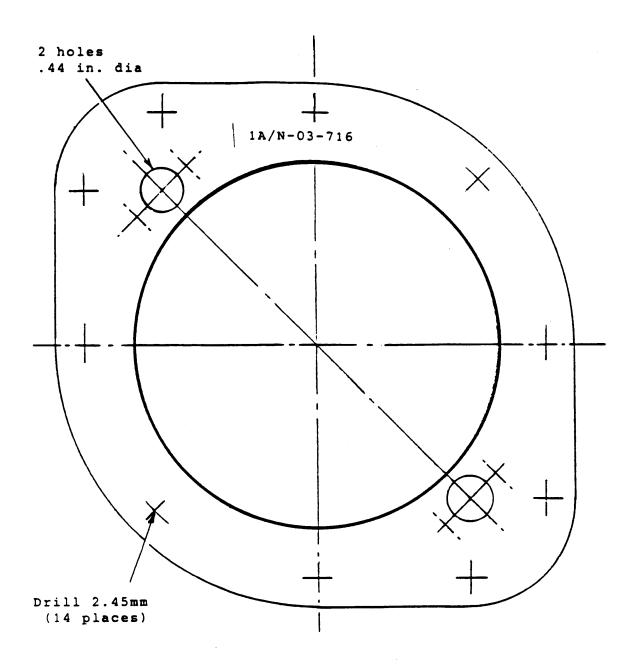
Template for Reinforcing Ring Figure 2

Refer to dimensions shown on Figure 1

Material - .020",2020-T3 Alclad QQ-A-250/5

- D. Position the re-inforcing ring and, using the re-inforcing ring as a template, drill out the holes for the rivets. Deburr holes and rivet re-inforcing ring in position using ten MS20470AD3-3 rivets. Repeat operation on opposite pod.
- E. Fit the cover plates and secure in position with 'Camloc' 2600-1 studs. Paint covers to match aircraft colour scheme.

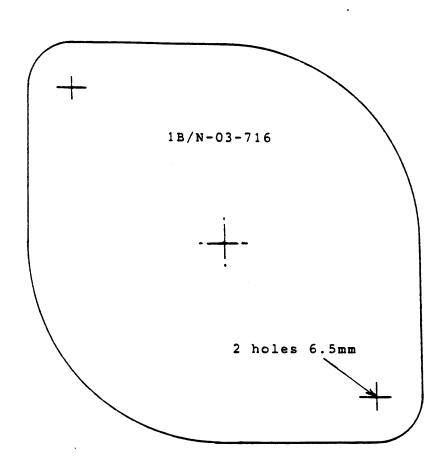
Template for Cover Figure 3

Refer to dimensions shown on Figure 1

Material - .020",2020-T3 Alclad QQ-A-250/5
