# Nomad

## SERVICE BULLETIN

### FUSELAGE — CENTRE SECTION — INSPECTION OF FRAME STA 212.97(N22)/240.97(N24)

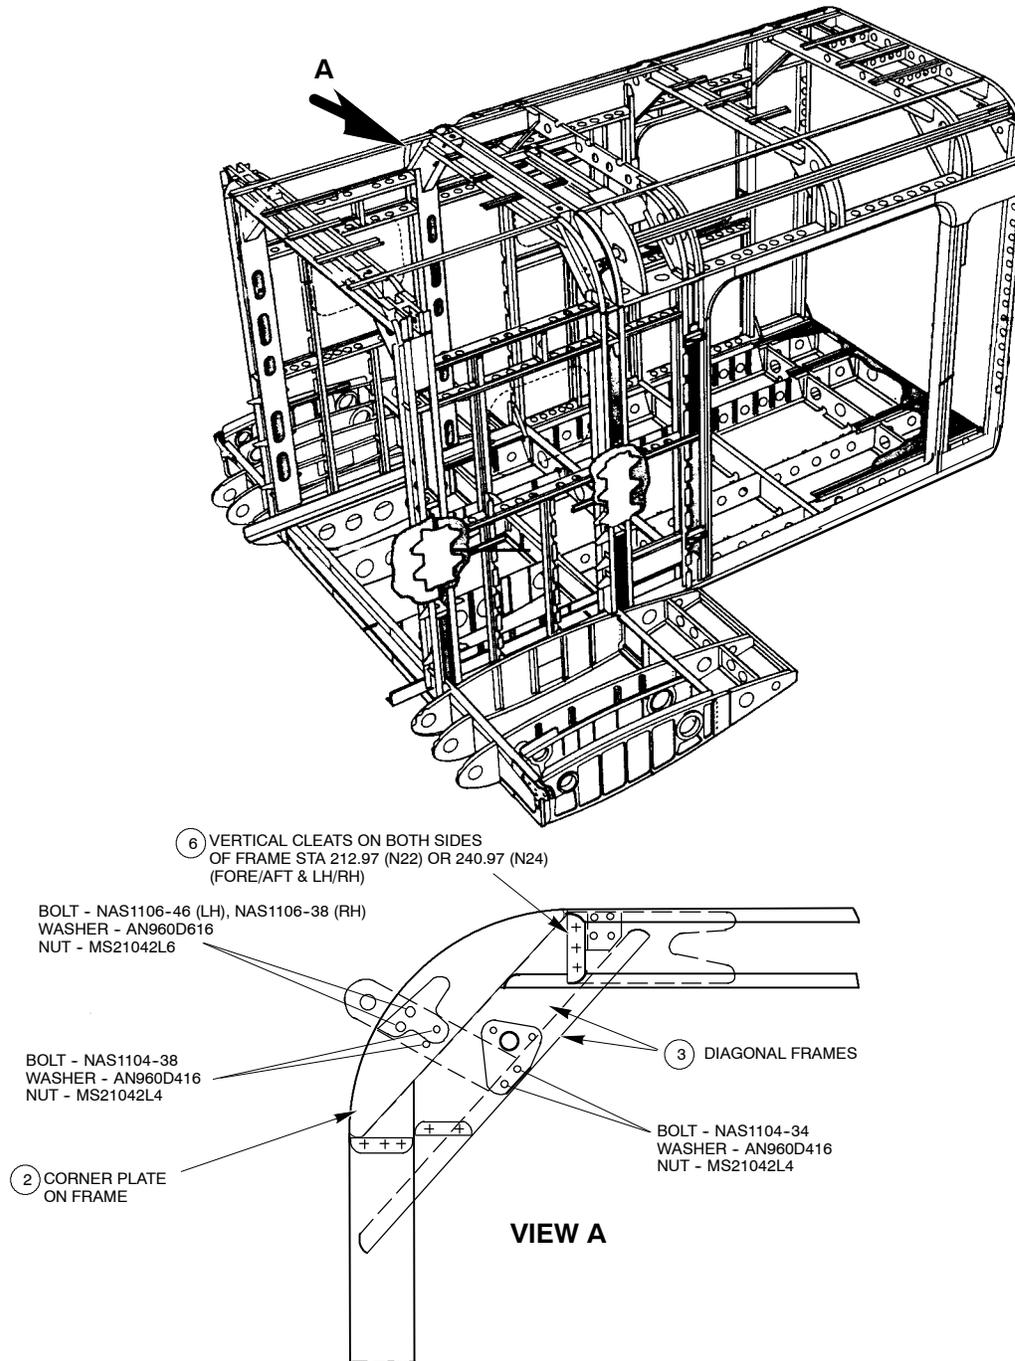
Figure 2 Centre Fuselage Section

- (b) Around rivet holes on the corner plates on both sides of frame (Ref Fig 2 & 3, Item 2).
  - (c) Around rivet holes on the fore, aft and inboard faces of both top diagonal frames (Ref Fig 2 & 3, Item 3).

- (f) The two vertical cleats (and attached longitudinal webs) on the aft side of the overhead frame (Ref Fig 2, Item 6).
  - (g) The fore, aft and lower faces of the overhead frame especially around the fastener locations (Ref Fig 3, Item 7).

- (b) Remove the six bolts (one at a time) that secure the wing rear spar attachment fitting to the frame (Ref Fig 2) and retain (or renew if necessary).
- (c) Using a borescope, perform a close visual inspection of the six bolt holes for cracks, corrosion and/or fretting. Alternatively, NDT inspection using eddy current equipment may be used for crack detection. Pay particular attention to the three layers of frame sheeting on either side of the wing attachment fitting for the four outermost bolts and two layers for the two lower bolts.

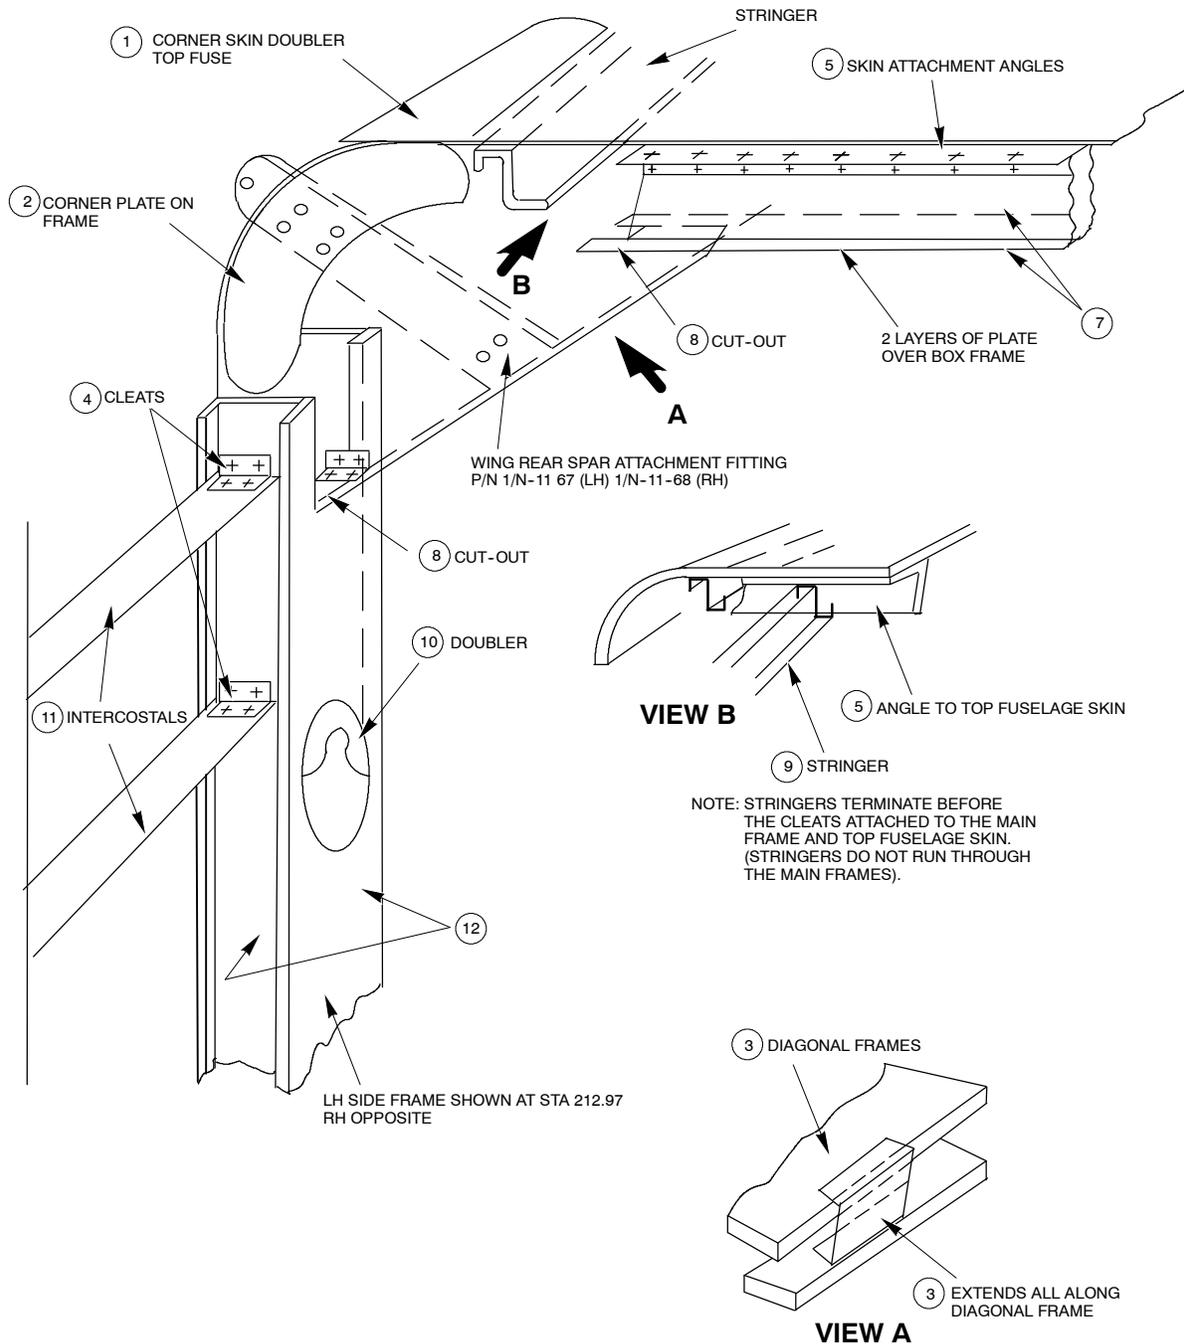
Figure 3 Frame Assembly, STA 212.97 (N22) or STA 240.97 (N24)

- (4) Visually inspect for possible cracking, the structure of the frame at sta 212.97(N22)/240.97(N24) and the surrounding structure as follows:
  - (a) The surface of the fuselage corner skin and doubler as visible through the access panels (Ref Fig 3, Item 1).

- (d) The cleat angles on both sides of frame (Ref Fig 3, Item 4).
  - (e) The skin attachment angles on both sides of the overhead frame (Ref Fig 3, Item 5).

- (h) The overhead and side frame at cut-outs where the top diagonal frame member slots into the side column (Ref Fig 3, Item 8).
  - (i) The top fuselage skins where the stringers terminate on both sides of the overhead member of frame (Ref Fig 3, Item 9).

- (j) The inside surface of all corner skins on both sides of frame around rivets attached to stringers and doublers.
  - (k) Doublers visible through the lightening hole on both side frames (Ref Fig 3, Item 10).

- (l) The fore, aft and inboard faces of both side frames (Ref Fig 3, Item 12).
  - (m) Around rivets in the intercostals fore and aft of both side frames (Ref Fig 3, Item 11).
