Nomad

SERVICE BULLETIN

INSPECTION OF STUB WING UPPER FRONT SPAR CAP FLANGES - REVISED INSPECTION PROCEDURE

NMD-53-22

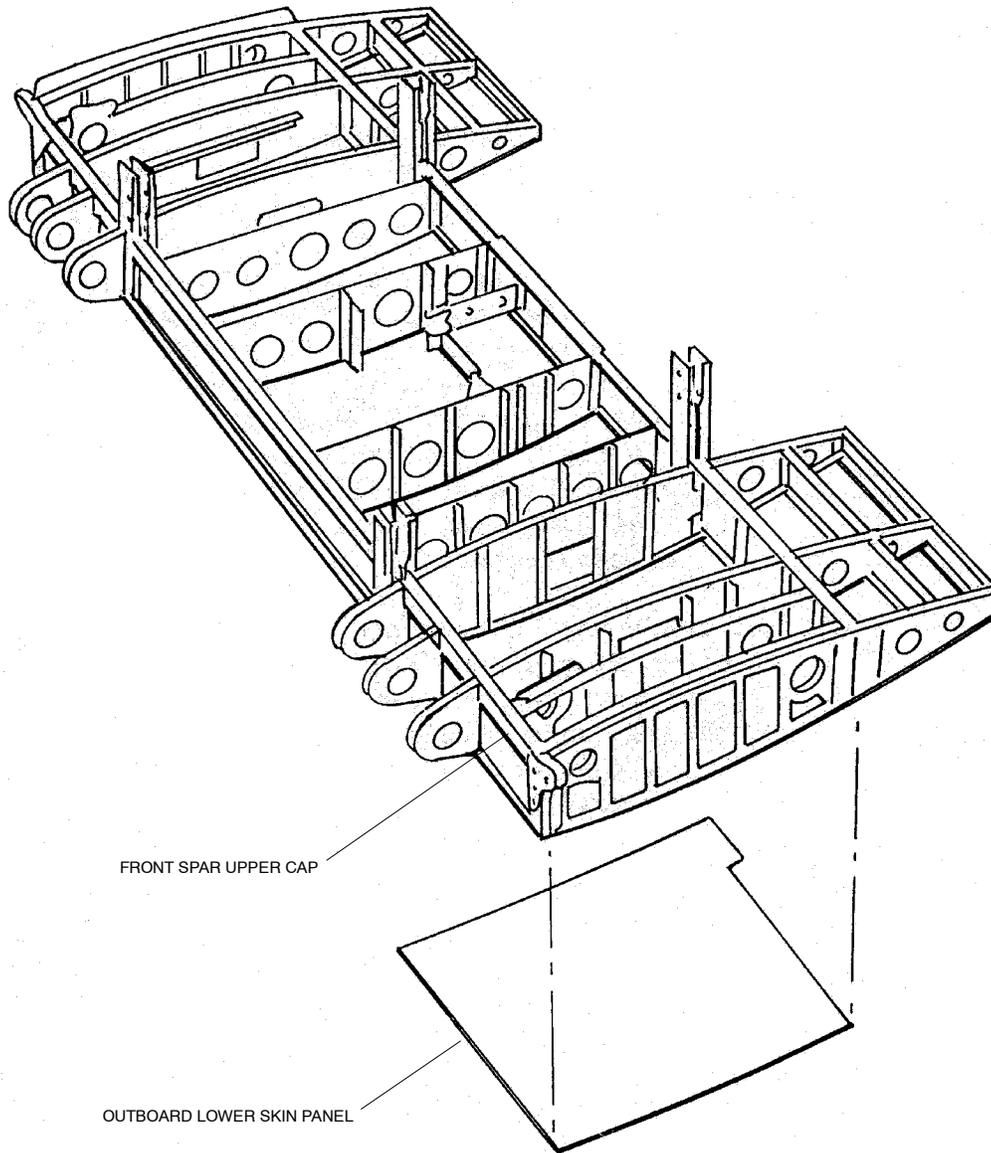
Figure 4 Stub Wing

- (1) An exterior inspection should be completed along the upper forward face of the stub wing front spar just inboard of the inner end of the wing strut attachment fitting as shown in Figure 4.
 - (a) Using a flashlight, visually inspect for possible cracks on the upper forward face of the stub wing front spar caps just inboard of the inner end of the wing strut attachment pick-up fittings (Ref Figs 4).

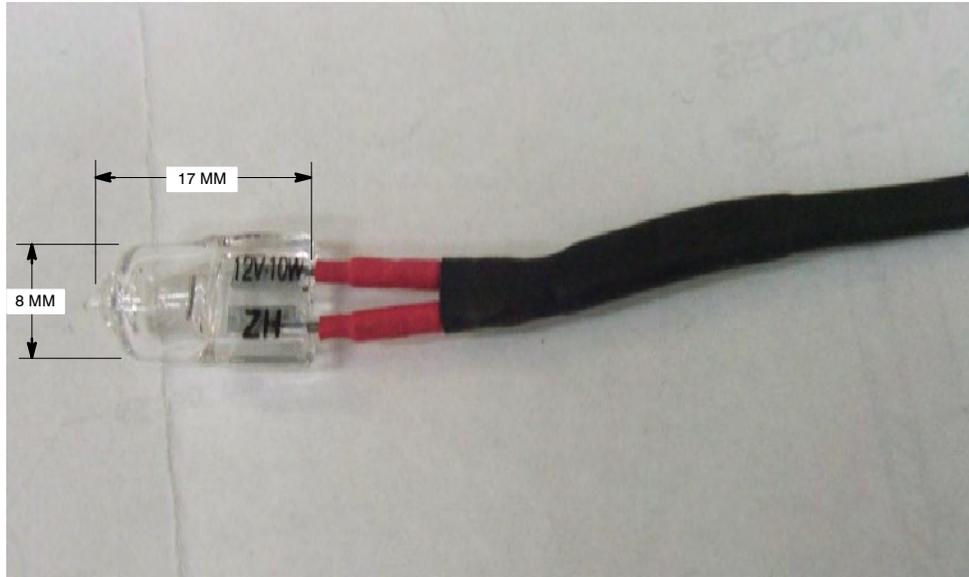
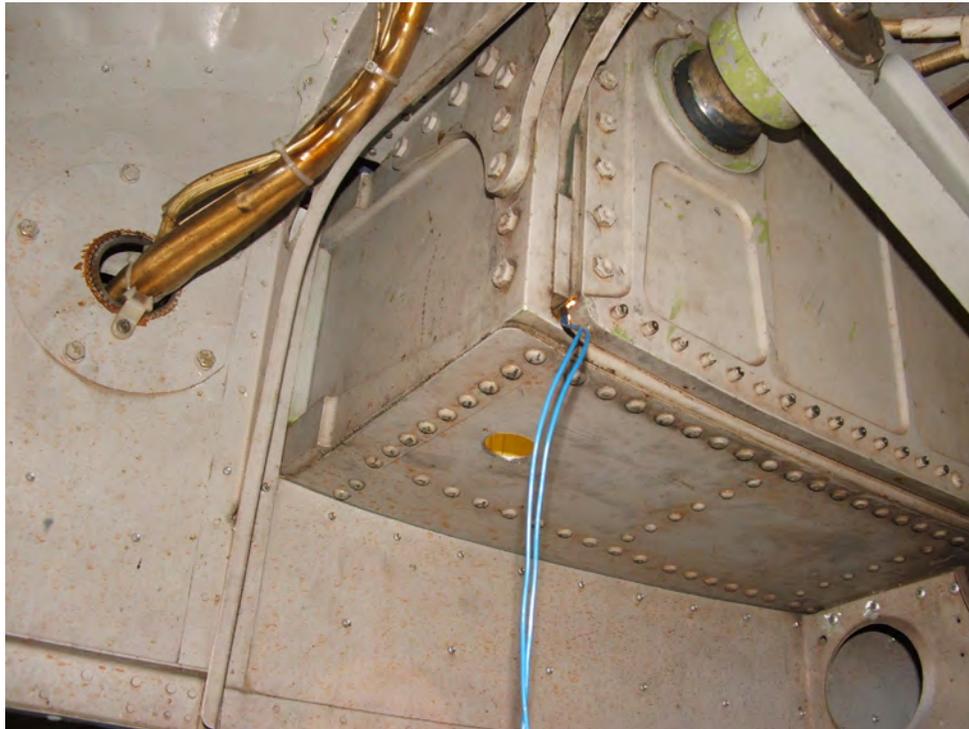
Figure 5 Stub Wing Bay Illumination

Areas around all six Huck bolts should be inspected using borescope or visually with the aid of powerful light source (Ref Fig 5) inserted via the clearance holes around the stub wing pickup fitting. A digital camera held at the inspection hole and using the light source will also assist in identifying defects.

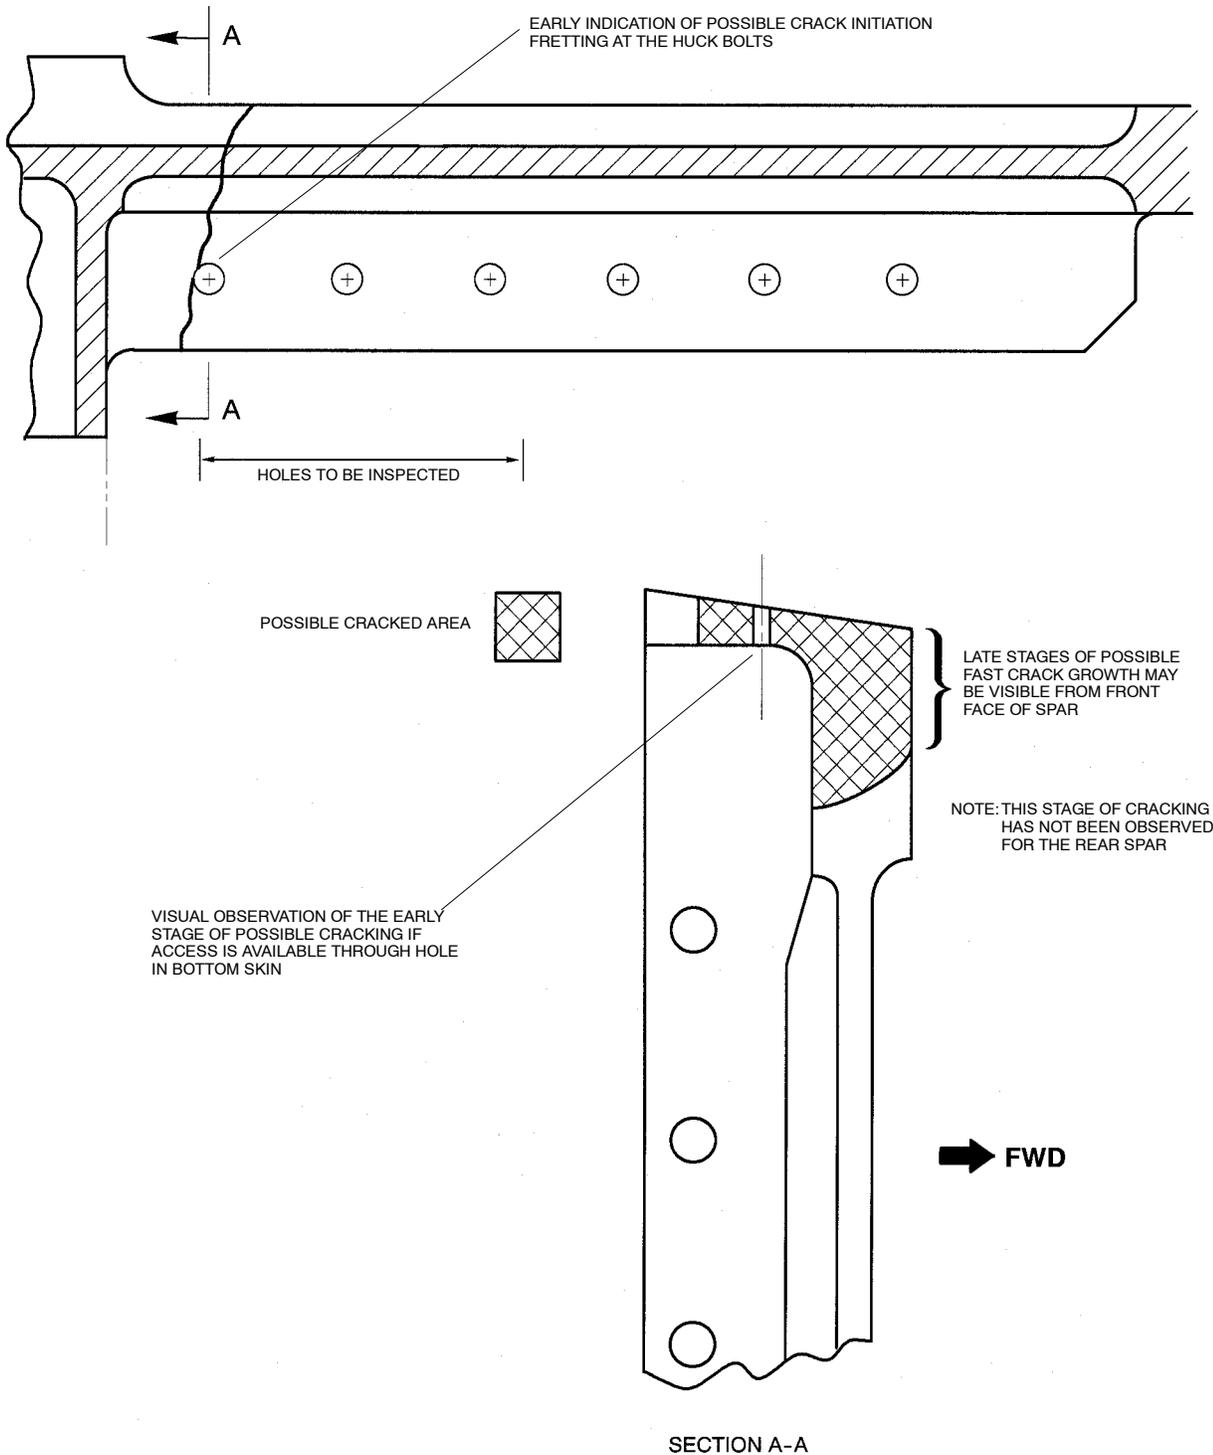
Figure 8 Likely Areas of Cracking

- (b) If any doubt exists, a magnifying glass, dye penetrant method, or eddy current method should be used.
- (2) An internal inspection should be carried out through the drilled inspection hole to examine for cracks in the upper Spar Cap around the upper Huck bolts (Ref Fig 8).

Potential cracks are most likely to form at the most inboard Huck bolts, with decreased likelihood at the others. Analysis has shown that the cracks are likely to grow toward the free edge before growing toward the spar cap as shown in Figure 8.

If any doubt exists as to the possibility of a crack, further examination should be undertaken by an appropriately qualified person, using a suitable eddy current pencil surface probe inserted through the access hole. It may be necessary to use a borescope in combination with the surface probe to correctly position the tip of the probe.
