Nomad

SERVICE BULLETIN

WINGS – TRAILING EDGE ACCESS DOORS SPOT WELDS – INSPECTION AND REPAIR

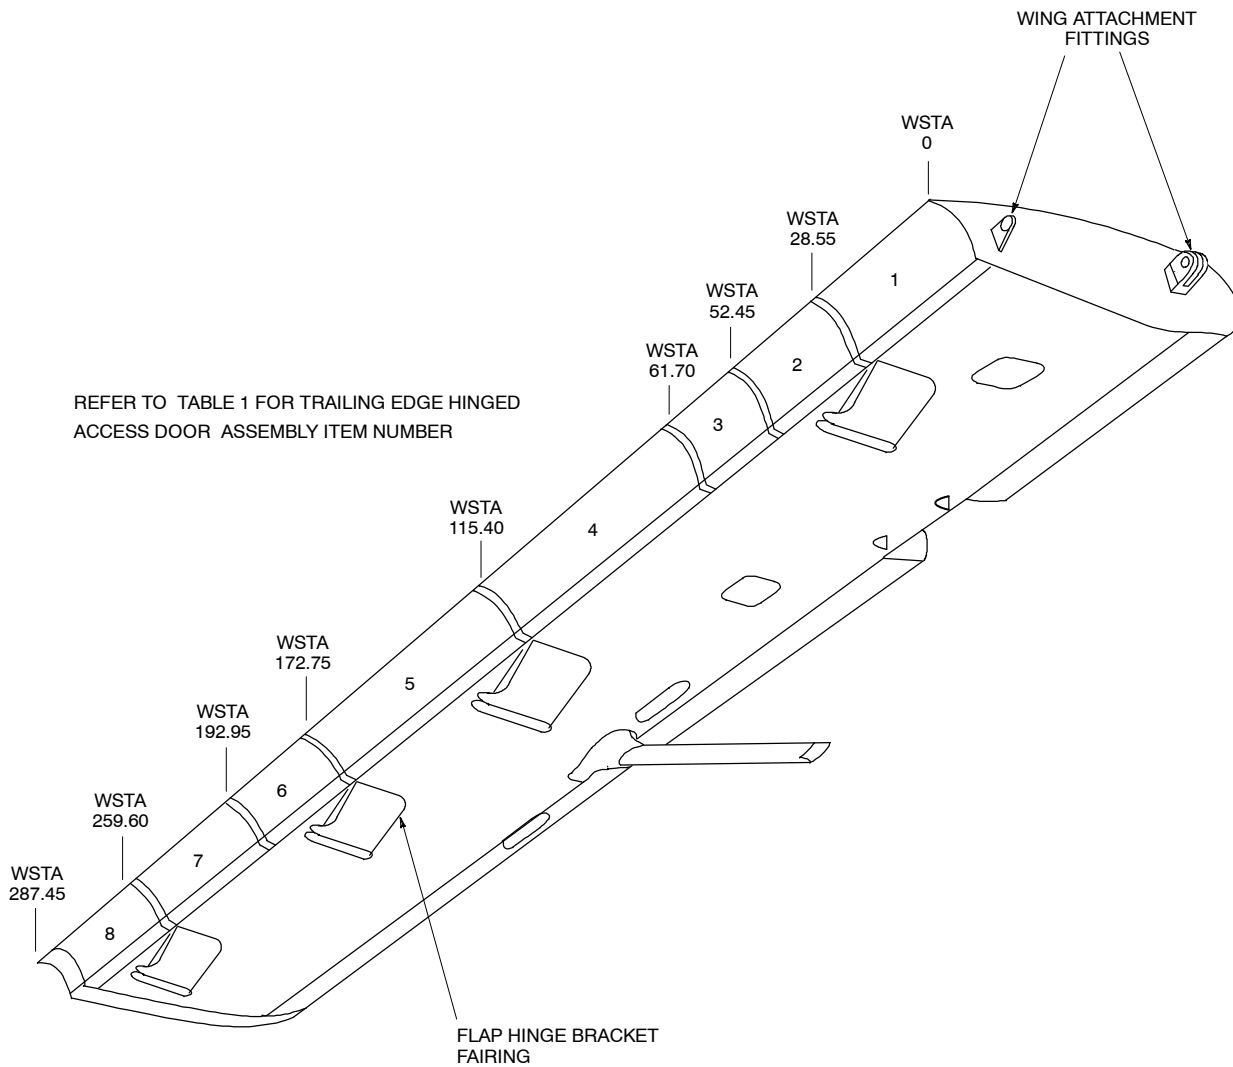
Figure 1 Wing Trailing Edge Doors

An inspection is to be carried out on all wing trailing edge doors from WSTA 0 to WSTA 287.45 for cracking around and adjacent to spot welds to determine the security of riblets, stiffeners and hinges.

Repairs are to be made to all wing trailing edge doors from WSTA 0 to WSTA 287.45. Spot welded components are secured by including additional rivets.

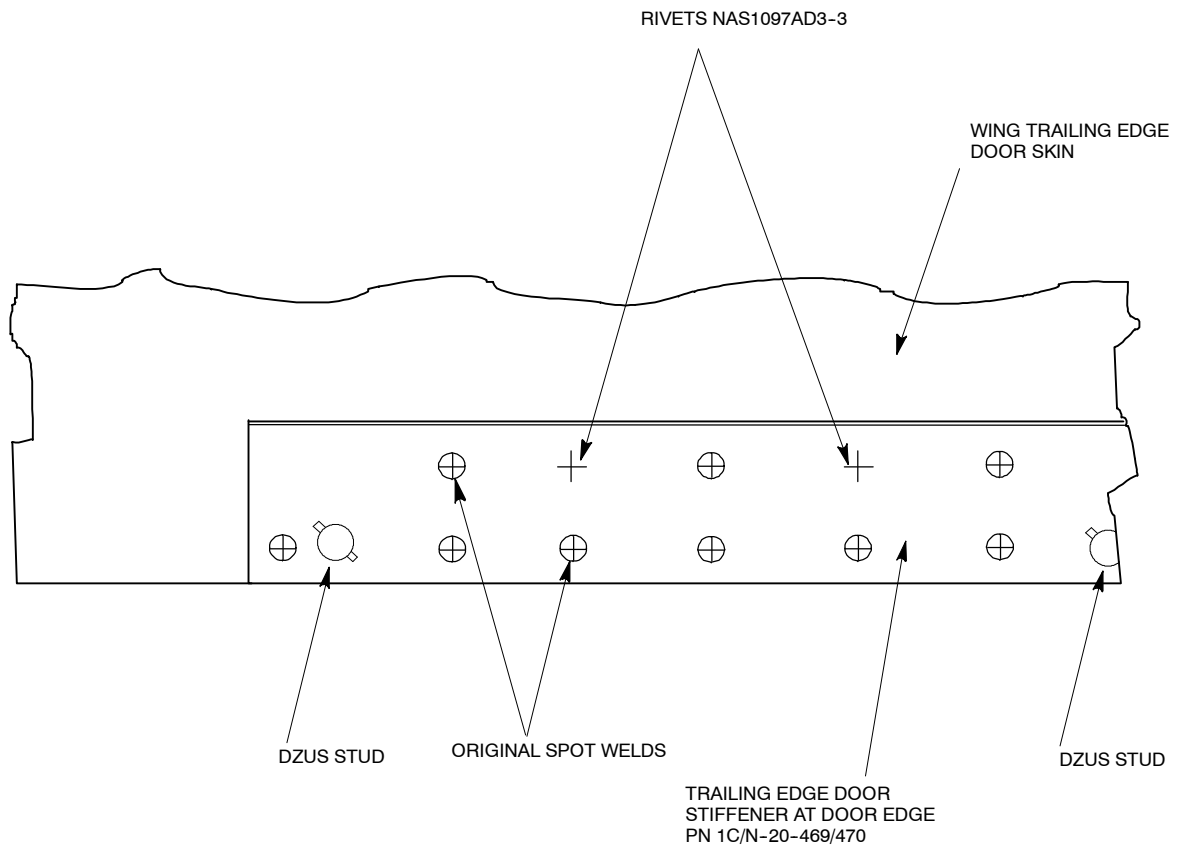
Figure 8 Trailing Edge Door Stiffener - at Door Edge

TYPICAL REPAIR FOR THE OUTBOARD END OF ITEM 5 (REF TABLE 1)

- 2 Wet install rivets NAS1097AD3-3 (rivet head on inside surface) using pigmented jointing compound (Ref Fig 7 & 8).
- (4) Close the left hand and right hand wing trailing edge door assemblies (Ref IPC 57-00-00).
- (5) Re-connect electrical power.
- (6) Retract the flaps (Ref MM 27-50-00).
