Nomad

SERVICE BULLETIN

SUBJECT: REVISION OF MAXIMUM CONTINUOUS POWER TURBINE
OUTLET TEMPERATURE

NMD-77-1
REVISION 1
Page 1 of 6

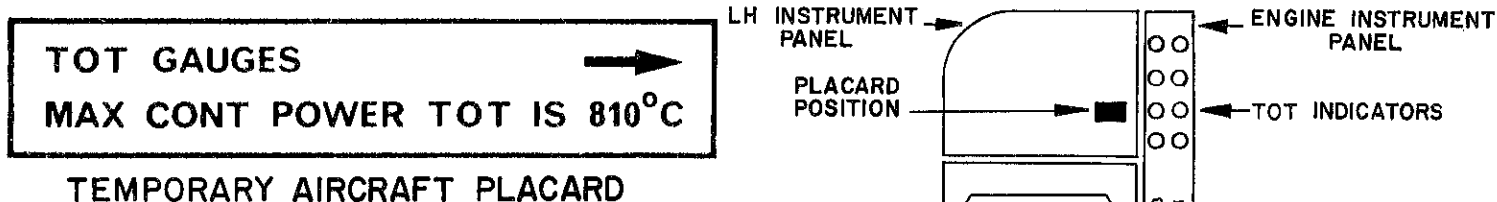
FIGURE 1

- (1) The temporary placard (Ref Figure 1) is to be locally made from suitable materials, e.g. thin white card and Letraset 12 Point Grotisque 216 Sheet 208 lettering, or embossing tape (Dymo or equivalent). Use template (Ref Figure 2) on Page 5 to assist in making the placard.
- (2) Attach the placard, using a contact adhesive to the LH instrument panel. The placard is to be located adjacent to the TOT indicators on the engine instrument panel.

- (3) Attach blue line at 810°C on the TOT indicators glass.

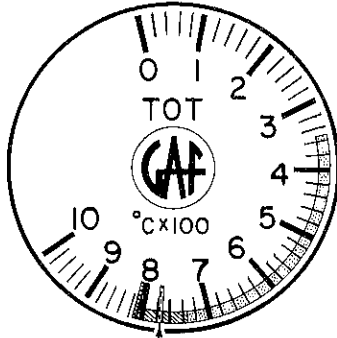
Rework of TOT Indicator
Figure 3

DELETE BLUE LINE AT 779°C

- b. Delete the blue radial limit marking at the 779°C position on the indicator dial by painting with instrument matt black paint or suitable equivalent.
- c. Restore full coverage of yellow band with yellow paint to Federal Standard 595 Colour No. 38907 where blue radial marking existed.
- d. Paint new blue radial at the 810°C position on indicator dial as shown on Figure 3.

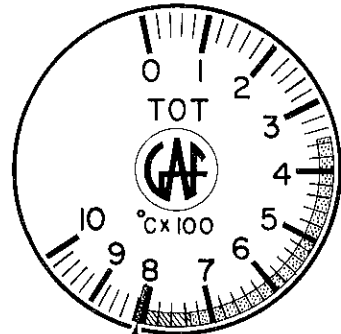
CAUTION: THE BLUE LINE MUST NOT BE PLACED OVER THE RED LIMIT MARKING AT THE 810°C POSITION (REFER FIGURE 3).

RED AND BLUE LINE AT 810°C
SAME SIZE AS EXISTING 100 MARKS
