SB-GA200-2015-10

MANDATORY

Service Bulletin

Enhanced Wing Front Spar Inspection

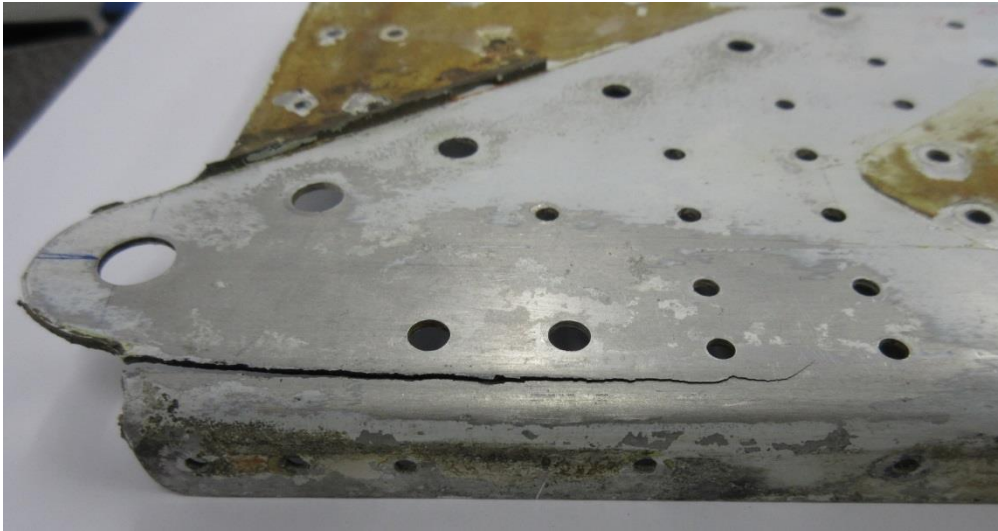
Operators of the GA200C have reported cracks developing in the Front Spar Web in the region of the Lower Cap at the wing root. These cracks have been found during incorporation of SB-GA200-2011-06, Wing Spar Life Extension, which is an optional Service Bulletin available from GippsAero. These cracks, if left unattended, may impact the structural integrity of the Wing.

Figure 1 – Crack in Front Spar

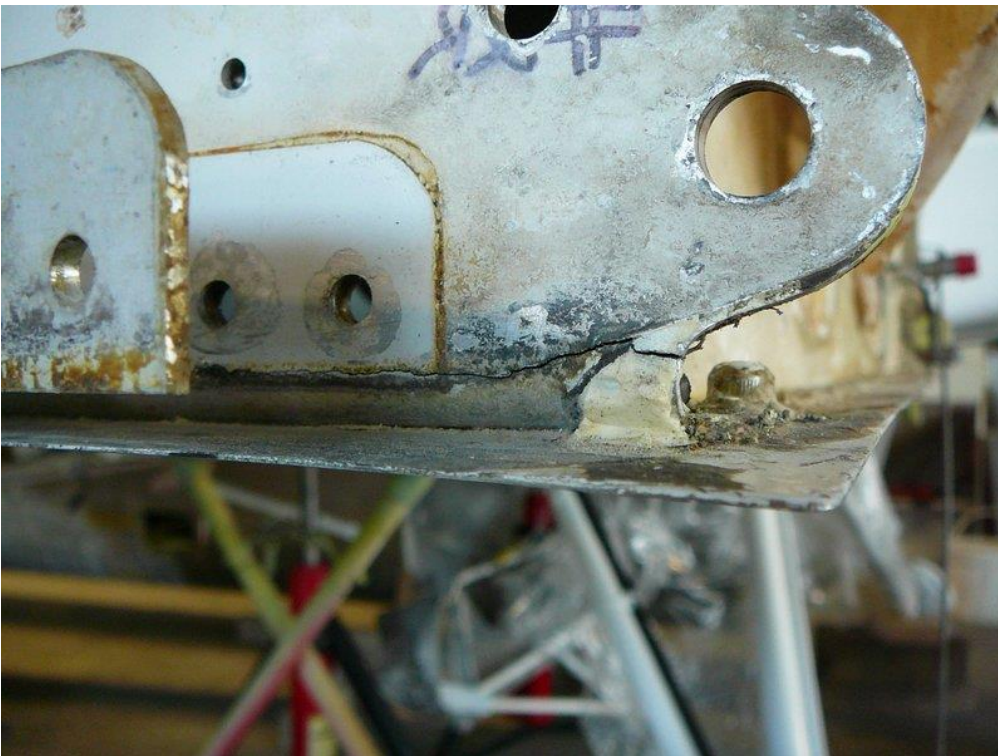
Figure 2 – Crack in Front Spar

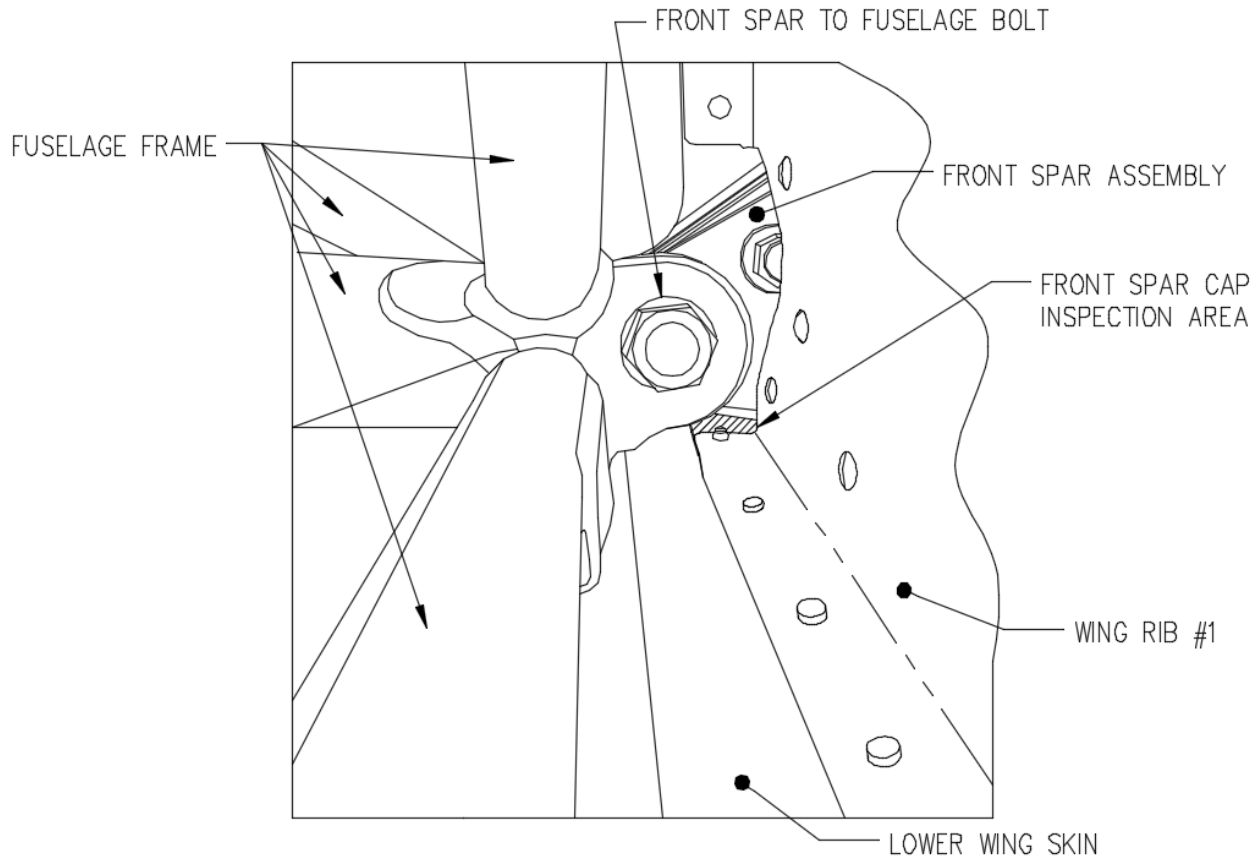
Use a strong light source and inspection equipment (such as mirrors or borescopes if available) to look for cracks starting at the edges and in the bend radius in the region shown in Figure 4.

Figure 4 – Front Spar Cap initial inspection area, RHS wing shown

5. If **no** cracks are seen, replace access panel on GA200/GA200C aircraft or restore Piper aircraft to a serviceable configuration. Inspection is complete.
6. If cracking is seen, do Part B, Part C and Part D.

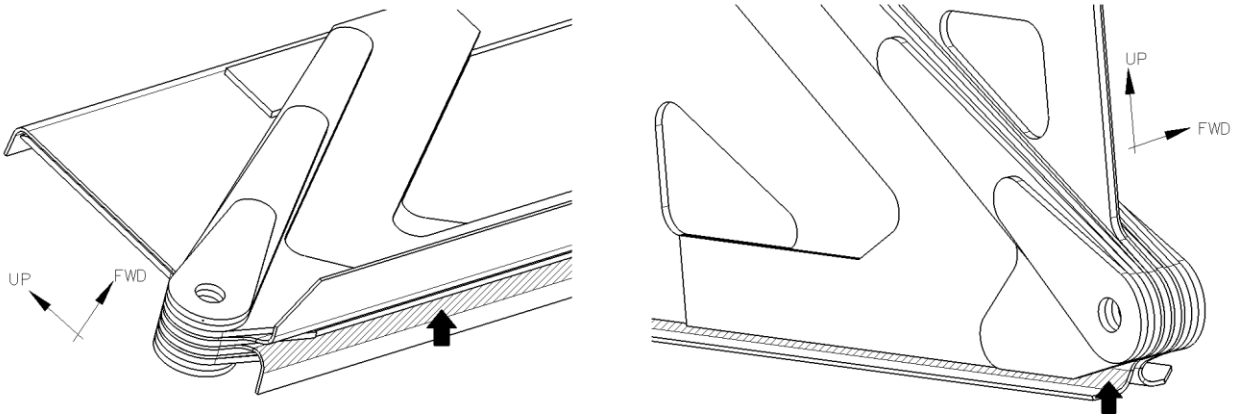
1. Clean the lower regions of the Front Spar using a cleaning solvent or other airframe cleaning compounds to help inspection.
2. Do a detailed visual inspection of the P/N GA200-571002-5, Front Spar Cap using at least 10x magnification and a strong light source. Look for cracks, notches or corrosion. Concentrate inspections at the root fitting end particularly around the relief under the lug area as shown in Figure 9.

Figure 9 – Concentrated area for inspection; LHS Spar shown

3. If any crack indication is observed, either replace the Front Spar Cap with a new part, replace the Front Spar Assembly or contact GippsAero for further instructions. Otherwise, continue.
4. Do a detailed visual inspection of the radius under the lug area. Look for any notches, dents, protrusions, corrosion or gouges that may cause a crack to start. If any of these are found, contact GippsAero. Otherwise, continue.
