MANDATORY

Service Bulletin

Cargo Door Forward Slide, operating rod and handle.

SB-GA8-2005-23
Issue 5

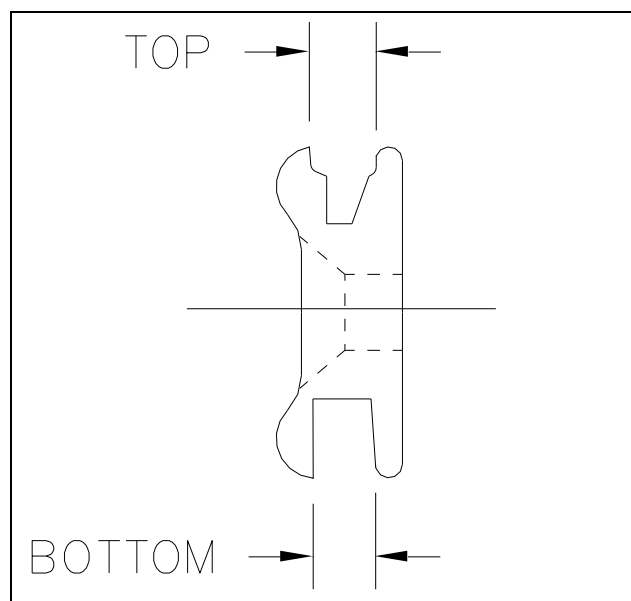
3. Figure 3 below shows how a worn part normally looks and where to measure the groove width. The TOP and BOTTOM profile differs on a worn part and as such both the top and bottom slide grooves are to be measured with a calliper.

Figure 3: Worn slider indicating where to measure.

4. Measure the groove width and if the groove is wider than 0.145" at any point along the slider or if the part is cracked or excessively worn a new slider, Item 1, must be fitted.
5. Irrespective of Item 1, Items 2 to 7 MUST be fitted as shown in Figure 4 and listed in below.

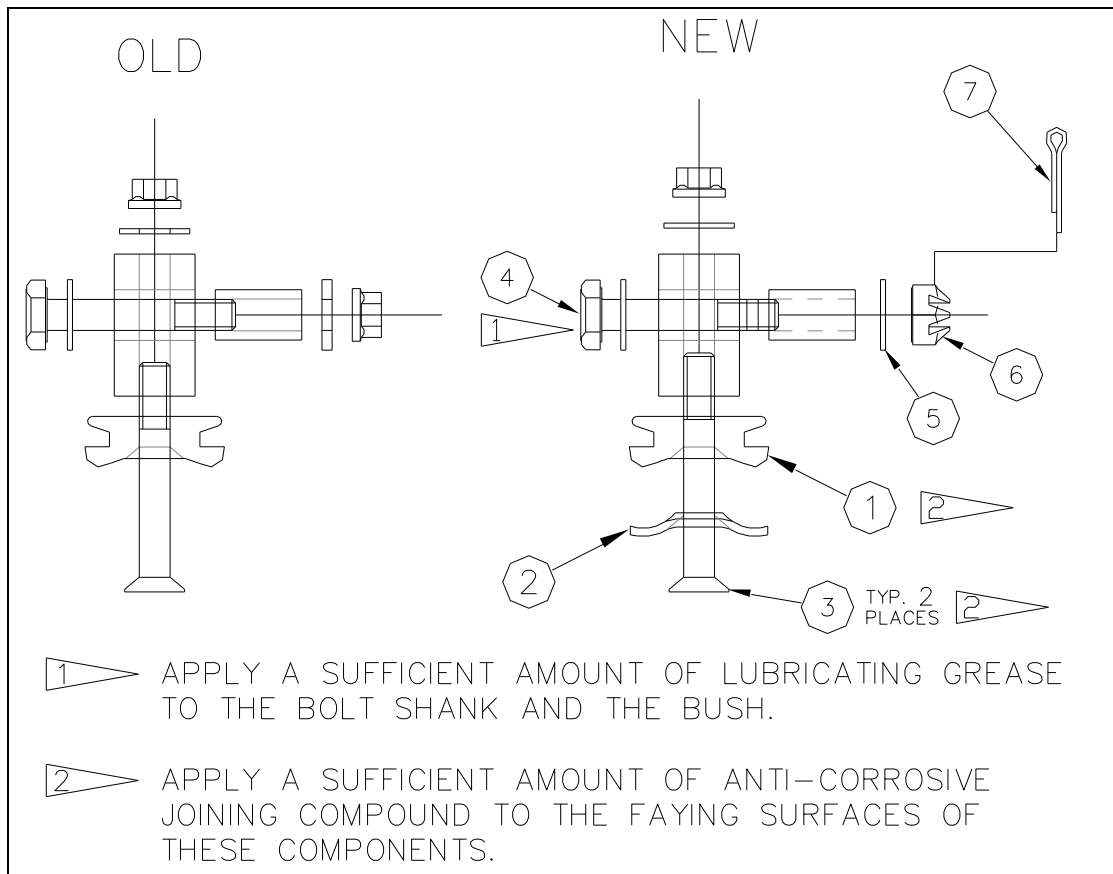
Figure 4: Old (left) and New (right) Forward cargo door slide.

- Reinstall new slider assembly and refit the Nylon Track End if it was removed.

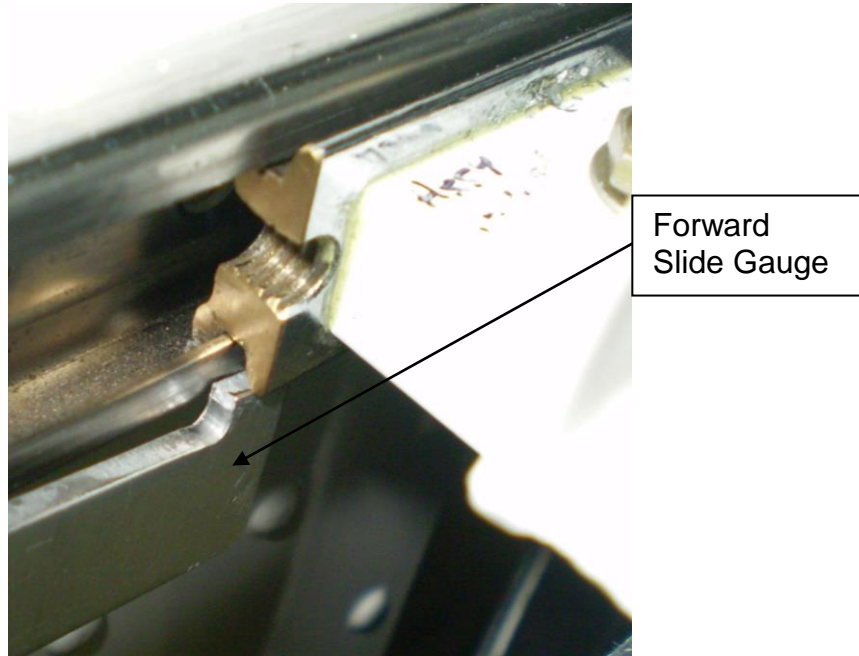
Figure 5: Checking with the Forward Slide Gauge (all four corners require checking)

3. If it is possible to fit the Forward Slide Gauge or feeler gauge between the track and slider (as shown in Figure 6 above) at any of the four corners carry out ACTION 1 Para 2 to 4.

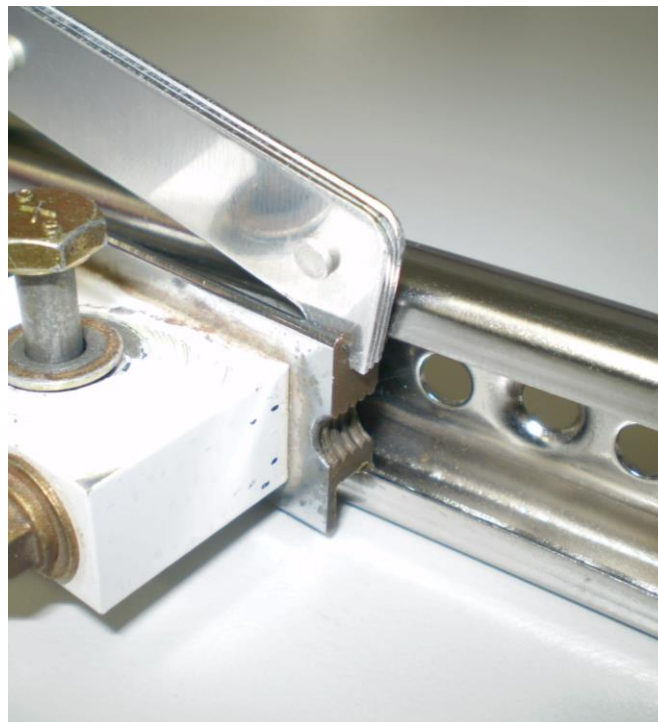
Figure 6: Forward Slide Gauge inserted between the slide and track, indicating a worn part. (Removed from aircraft for clarity only, checking can be done while installed)

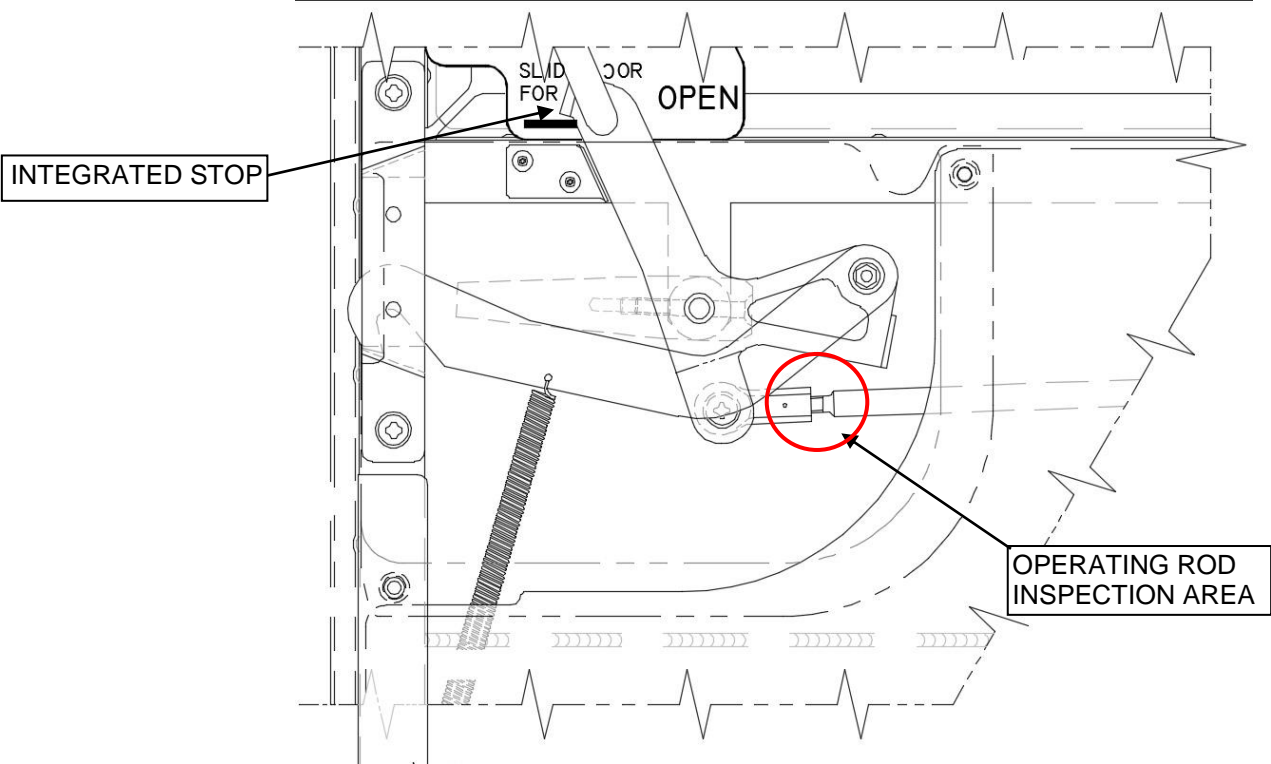
Figure 8: Rear Door Handle Mechanism - Inspection Areas

1. Remove Rear Mechanism Cover, refer to Figure 7.
2. Inspect threaded stud at the end of the operating rod, refer to Figure 8. If there is any indication of bending then either replace the operating rod with Item 9 from Table 3 or locally modified rod detailed in Part B2 using the following steps.
3. Disconnect the rod ends from the handle and pivot arm. Remove the forward rod end and pull out the operating rod.
4. Install the operating rod through frame bush prior to installing forward Rod End. Install rod ends and connect to the handle and pivot arm.
