Service Bulletin

Inspection of the Main Undercarriage Axle Assembly

SB-GA8-2016-169

Issue 3

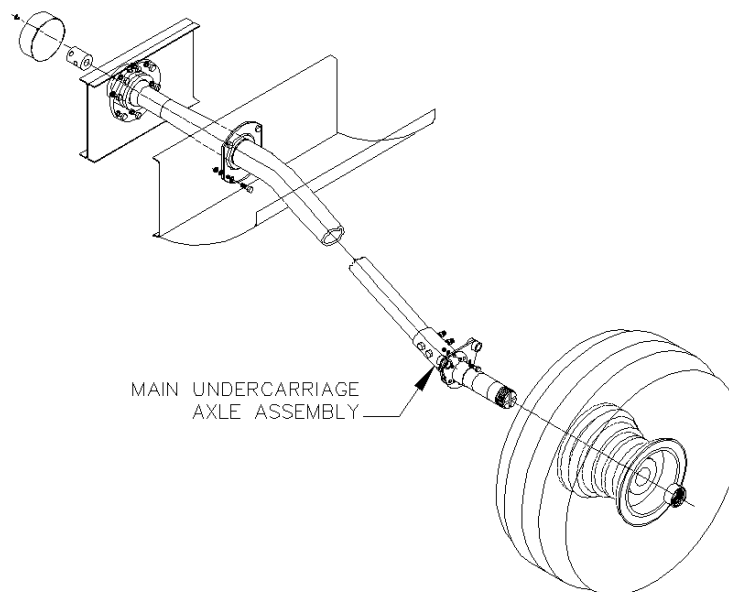
Figure 1 – Main Undercarriage

An Operator of a GA8 recently suffered an in-service failure of the Main Undercarriage Axle Assembly, P/N GA8-321013-011. The failure was due to a crack which was found on the upper side of the Axle on the inboard side of the Brake Torque Plate. Cracks have been reported as visible on the outside and inside of the Axle as shown in Figure 1 and Figure 2.
