Service Bulletin

Corrosion inspection of the horizontal stabiliser frame tubes.

All GA200 aircraft.

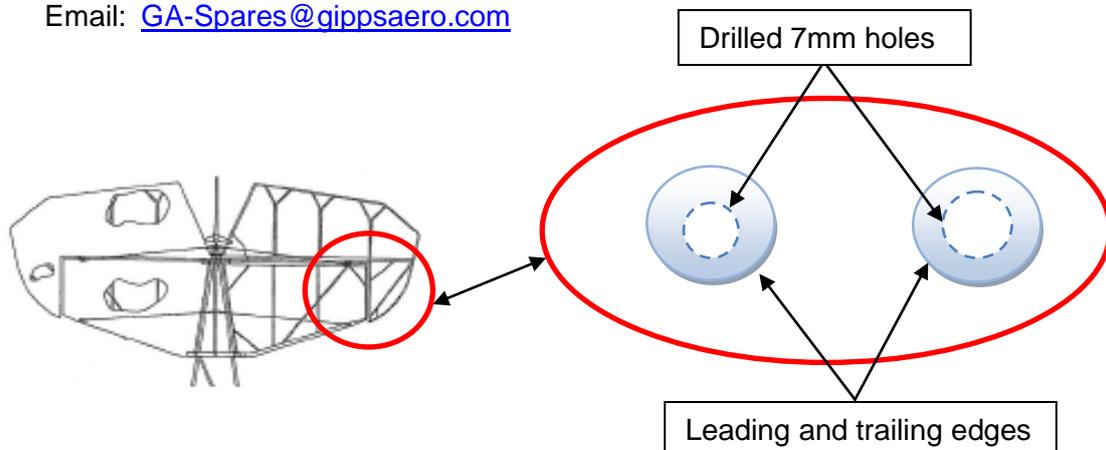
FIG 1

ONLY THE PORT (LEFT HAND SIDE) OF THE HORIZONTAL STABILISER ILLUSTRATED.

1. Remove the elevator. (Refer to GA200 Service Manual section 27-30-00)
2. Carefully remove the fabric around the end caps of the leading and trailing edge tips.(Fig 1). If this is a repeat inspection, remove plastic caps from inspection holes and proceed to **Step 4**, otherwise action **Step 3**.
3. Carefully mark the centre of the tube tip caps and drill a seven millimetre (7 mm) hole in the end caps of the leading and trailing edges (Ensure that all swarf is captured and the holes deburred).
