Service Bulletin

Crew Seat Inspection.

Document: Service Bulletin SB-GA8-2003-09

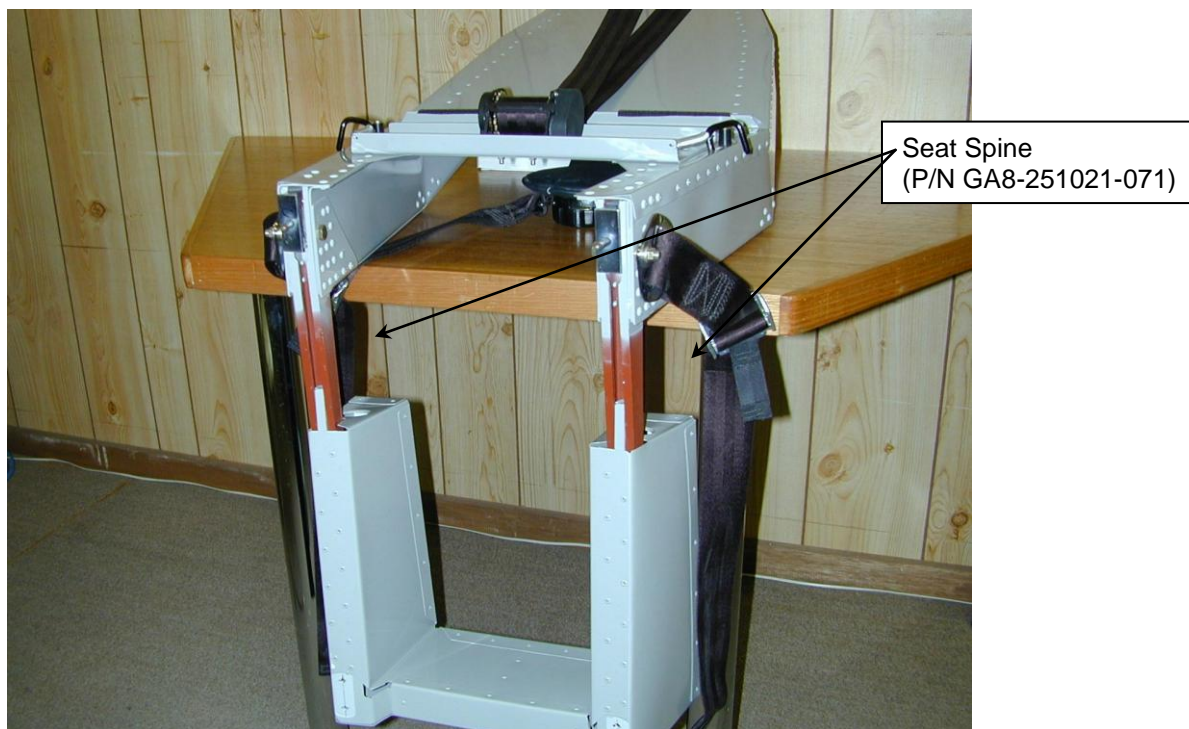
Figure 1. Seat positioned for inspection

During manufacture, the steel spine, between the front and rear seat feet, may have been notched. Gippsland Aeronautics has determined the maximum allowable notch size and all crew seats must be inspected to ensure that any notches are below the maximum size.

1. Remove the crew seat travel stops and then the crew seats from the aircraft.
2. Unscrew the forward seat feet (P/N GA8-251021-075) and slide the seat base (P/N GA8-251011-025) forward as far as possible. The base should move forward about 4 inches and the steel spines (P/N GA8-251021-071) will be visible, see figure 1. It is only necessary to inspect for notches in the aft visible portion of the spine.

3. Inspect the spines for drill spots. Any circular spots less than 0.135" diameter may be left as is, however, drill spots deep enough to have parallel edges are not allowed. Any marks impacting the edge of the spine, producing an effective chamfer up to a maximum dimension of 0.050" by 0.050", must be carefully blended out. Extensions of the edge marks, caused by the drill sliding off the edge, which are less than 0.010" deep are allowed.

When blending out the marks care must be taken not to reduce the cross sectional area any further and the blending should extend 10 times the mark depth either side of the mark.

4. If drill spots greater than 0.135" diameter, drill spots deep enough to have parallel edges or edge marks with a maximum dimension greater than 0.050" are found, contact Gippsland Aeronautics.
5. If the circular marks are less than 0.135" diameter or any edge marks have a maximum dimension less than 0.050", renew the corrosion protection, reassemble the seat in the reverse order of disassembly and return the seat to service. Ensure seat stops are reinstalled and perform a function check on the seat pins.
6. Enter compliance with this service bulletin in the aircraft log books.
7. In all cases where the inspector has any doubts or concerns over the inspection method or results Gippsland Aeronautics may be contacted to provide technical support.
