Service Bulletin

Installation of rear spar adjusting bushes.

All GA8 serial numbers GA8-00-004 through GA8-04-053.

DOCUMENT: Service Bulletin SB-GA8-2004-12

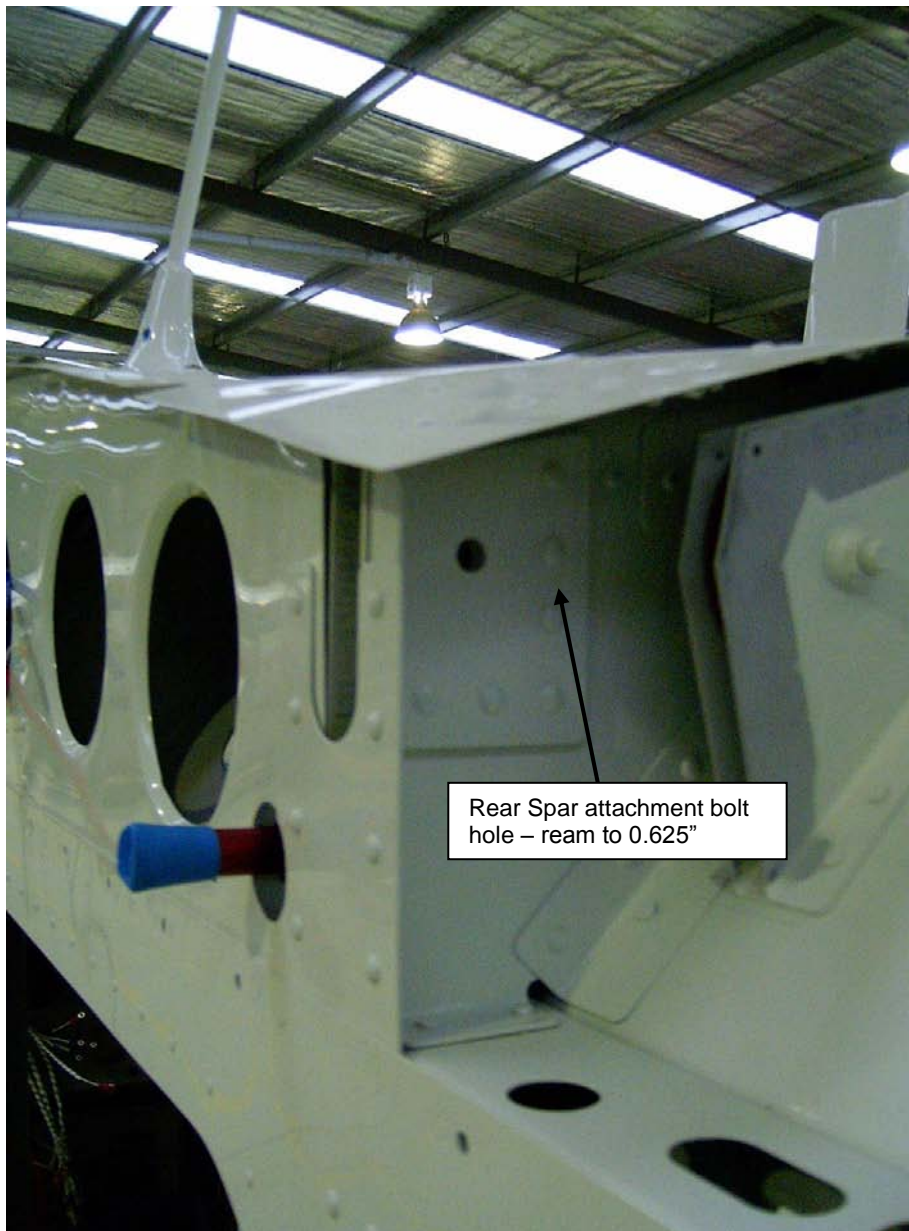
Figure 1

This Service Bulletin documents the installation procedure for aircraft not fitted at production of rear spar adjusting bushes on the left hand wing to enable precise correction of a wing low flight condition.

1. Remove LH wing assembly (if fitted) per section 57-10-10 *Wing Removal and Installation* of the GA8 Service Manual.
2. Ream the hole for the rear spar attachment bolt to 0.625". Refer to Figure 1.

USE EXTREME CARE WHEN REAMING THE REAR SPAR ATTACHMENT BOLT HOLE, EXTENSIVE REPAIRS MAY BE REQUIRED SHOULD ANY SURROUNDING STRUCTURE BE DAMAGED OR THE HOLE BE REAMED OFF CENTER OR TO A DIAMETER GREATER THAN 0.625".

3. Install rear spar adjusting bushes in reamed hole, ensure all contacting surfaces are coated with anti-seize.
4. Reinstall and rig wing per section 57-10-10 *Wing Removal and Installation* of the GA8 Service Manual, replacing the AN5-14A bolt removed from rear spar attachment with an AN5-16A bolt.
5. Screw holes in lower wing root fairing P/N GA8-570028-27 may be slotted to a length of 0.25" if required for ease of installation.
