# Service Bulletin

Horizontal Stabiliser Aft Pivot Modification

All GA8 serial numbers GA8-00-004 through GA8-04-060.

Document: Service Bulletin SB-GA8-2005-21

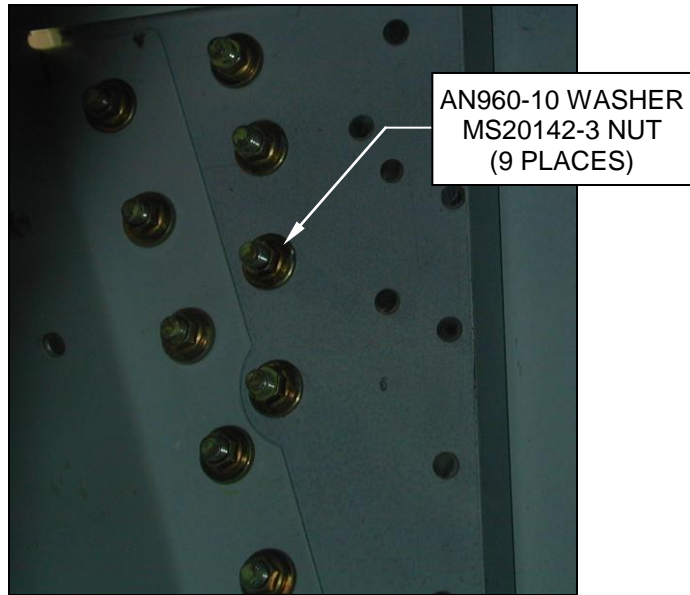
**Figure 1: Finished modified pivot installation (looking from inside the aft fuselage).**

6. Drill a lubrication hole with diameter  $0.078" \pm 0.005"$  ( $1.984 \pm 0.127$  mm) in the pivot brackets as per figure 4, and chamfer the outer edge of the hole  $0.05" \pm 0.005"$  ( $1.27 \pm 0.127$  mm) with a  $45^\circ$  countersink.
7. Install the brackets using items 3, 4, 6, and 8 as per figures 1 and 2. Pack bolt threads with thin washer (item 4) under the bolt head, and a washer (item 3) under the nut (item 6).
8. Attach the stabiliser aft pivot channel mount to the fuselage pivot bracket using items 1, 2, 5, 7 and 9 as per figures 2 and 3.
9. Lubricate the bushes using general-purpose grease through the lubrication holes in the brackets.

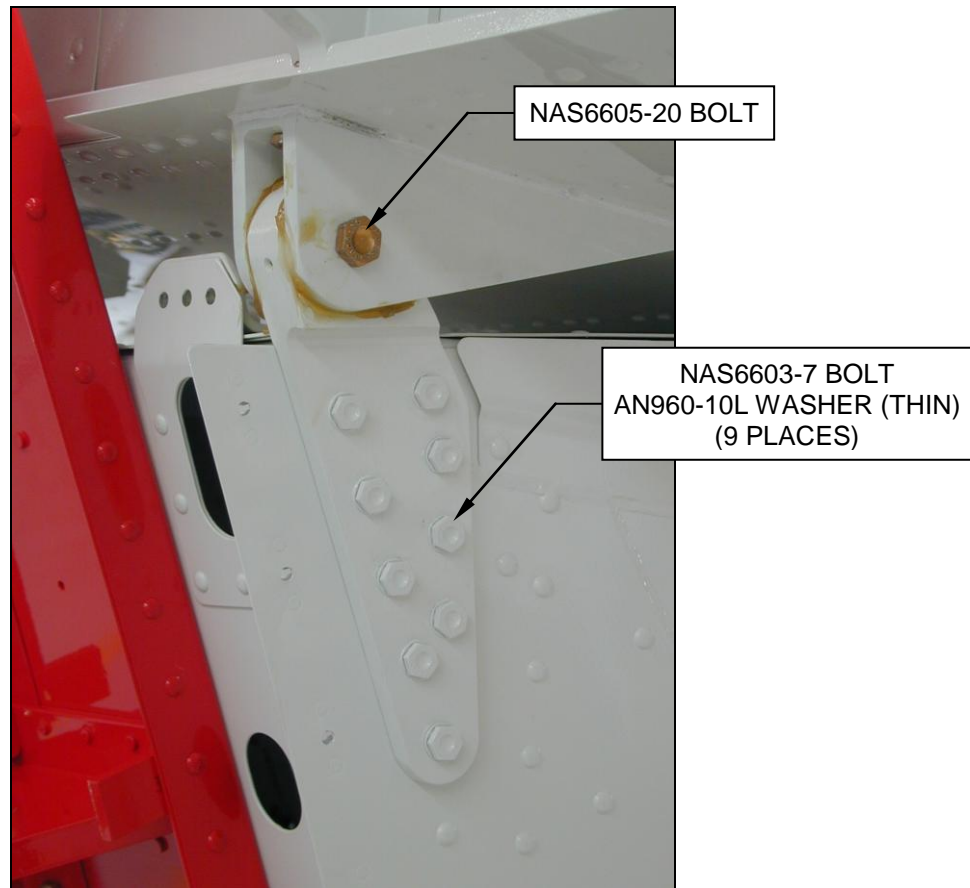
**Figure 2: Finished modified pivot installation.**

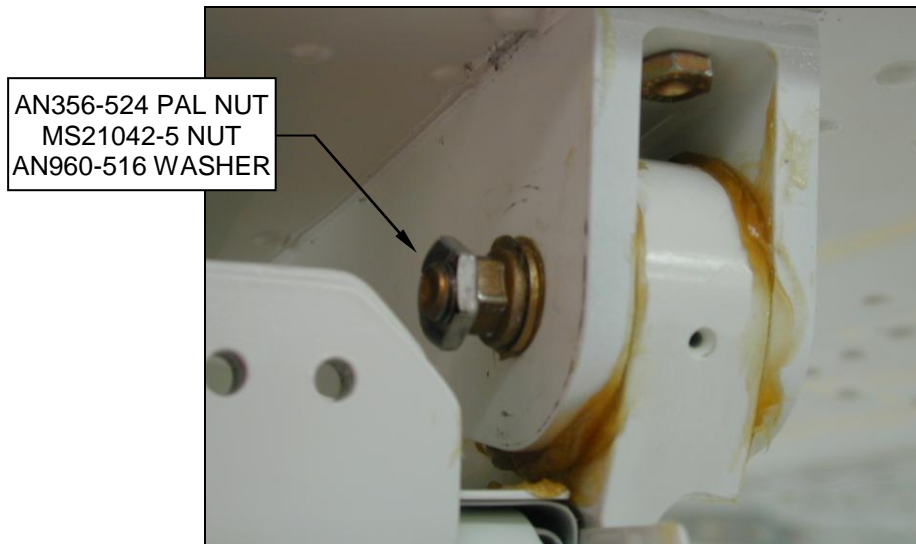
**Figure 3: Finished modified pivot installation.**

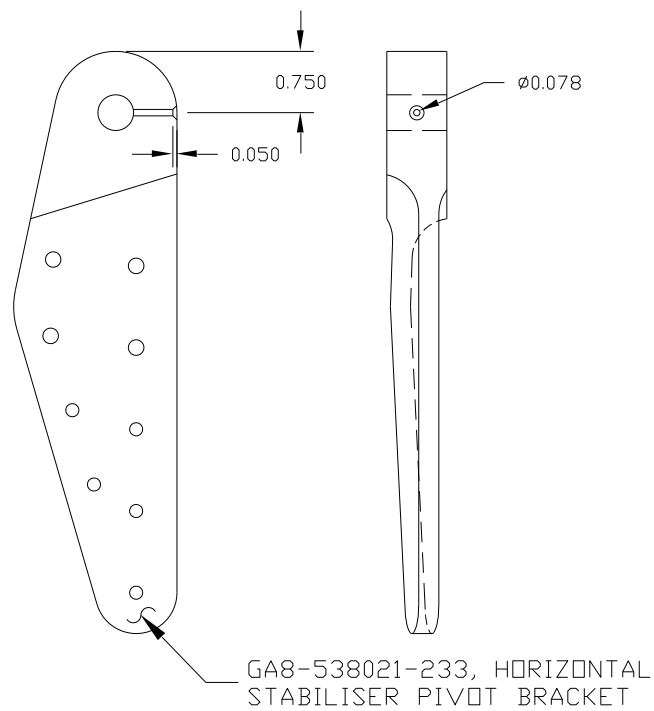
**Figure 4: Lubrication hole geometry.**
