Service Bulletin

Seat Track Stops

All GA8 serial numbers up to S/N GA8-05-088

Document: Service Bulletin SB-GA8-2005-29

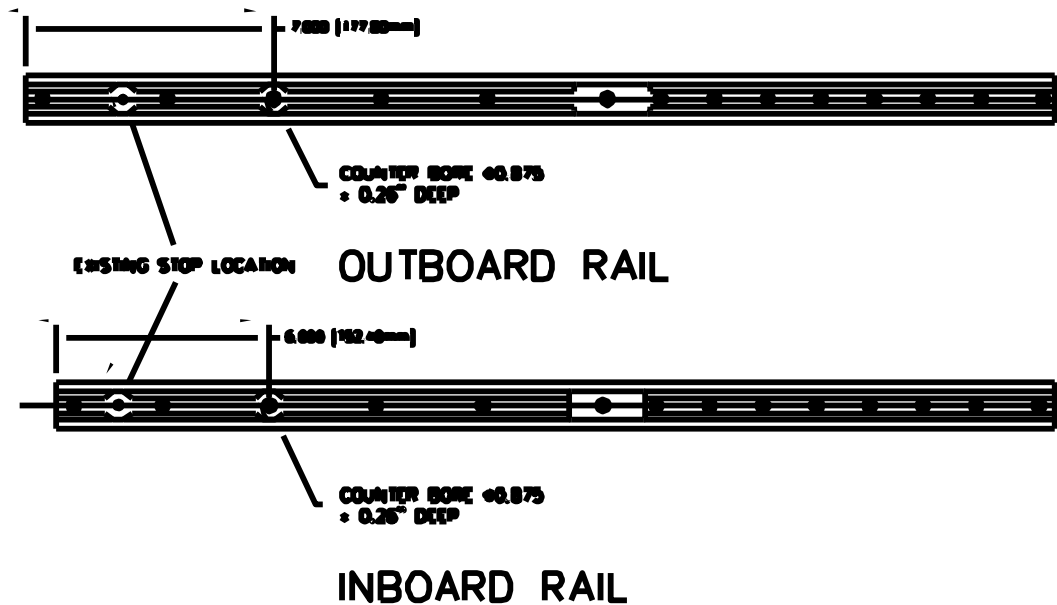
Figure 1

The current location of the pilot and second occupant seat stops allows for the possibility that at either seat's most forward position, aft movement of the control column is restricted by the seat structure. This Service Bulletin relocates the seat stops to eliminate this possibility.

- 1.3. Rework the seat track rails to position a new seat stop recess concentric with the third screw position in each rail as per Figure 1.

TAKE CARE TO ENSURE THAT THE BOTTOM OF THE RAIL CUTOUT IS NOT DAMAGED OR OTHERWISE MARKED DURING THE REWORK OPERATION.
