# Service Bulletin

Oil cooler front baffle modification

All GA8 serial numbers up to S/N GA8-05-095

Document: Service Bulletin SB-GA8-2006-34

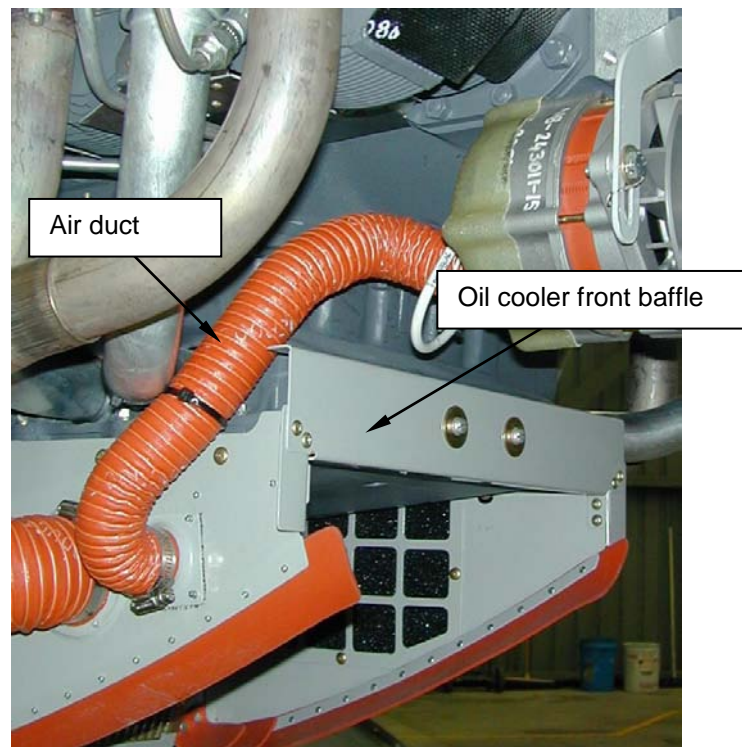
Figure 1

The air duct connecting the alternator shroud to the air intake plenum has been observed on some aircraft to be a tight fit between the engine and the oil cooler front baffle. This service bulletin reworks the oil cooler front baffle to give additional clearance for the air duct. Alternatively a new revised oil cooler front baffle may be installed.

- 1.1 Remove upper and lower cowls to gain access to the oil cooler front baffle. Refer to Figure 1.
- 1.2 Remove the oil cooler front baffle from the air intake assembly.
- 1.3 Taper the right hand end of the top flange of the oil cooler front baffle to provide additional clearance to the air duct. The maximum permitted length of the taper is 2.0". Refer to Figure 2.
- 1.4 Prime the trimmed edge with a suitable primer, such as zinc chromate primer.
- 1.5 Replace the oil cooler front baffle.
- 1.6 Refit cowls.

- 2.1 Remove upper and lower cowls to gain access to the oil cooler front baffle. Refer to Figure 1.
- 2.2 Remove the existing oil cooler front baffle from the air intake plenum.
- 2.3 Install new oil cooler front baffle.
- 2.4 Refit cowls.
