# Service Bulletin

Overheating of overhead electrical connection used by cabin fresh air blower.

All GA8 aircraft with serial numbers GA8-00-004 to GA8-06-104, GA8-06-106, GA8-06-107, GA8-07-109 and GA8-07-111.

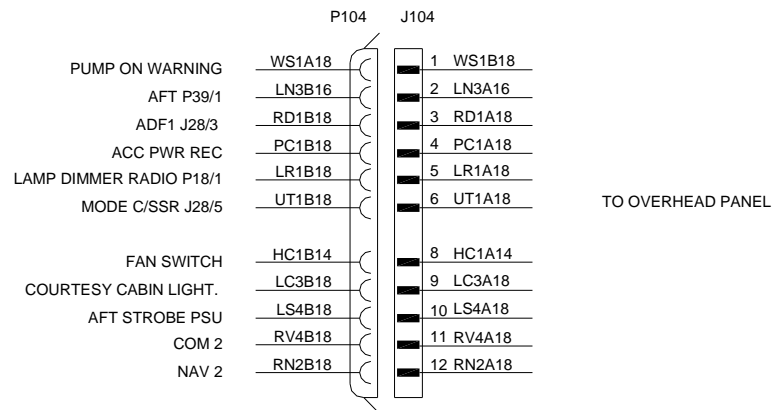
- 1.1. Pull or open all the underfloor circuit breakers.
- 1.2. The affected connectors P104 and J104 are located port side just aft end of the electrical overhead panel. Refer to Figure 1. Remove the forward most centre interior roof panel to access the connectors. Pin 8 of the connectors are used for the blower fan circuits, HC1A14 and HC1B14.

- 2.1. Replace the electrical plug and cap housing and associated crimp contacts as per original aircraft wiring. Connector P104 requires housing part number 1-480708-0. Connector J104 requires housing part number 1-480709-0. Refer to Figure 1 of this Service Bulletin for the pinout for each connector. The 18 AWG wires require crimp contacts part number 350689-1 & part number 350690-1. Crimp contact part numbers 350547-1 and 350550-1 are used on the 14 and 16 AWG wires. Crimp tool HTR 11-01-0084 (Sargent Tools) is recommended for this task. Use nest A for 18 AWG wire and nest B for the 14 and 16 AWG wires.

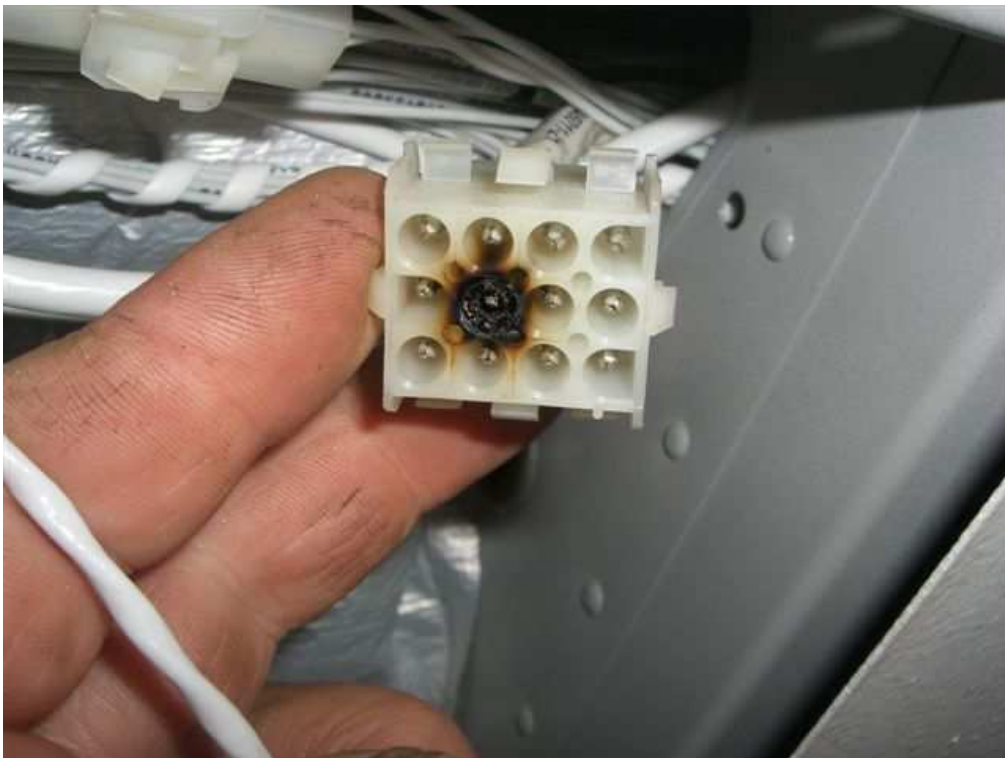
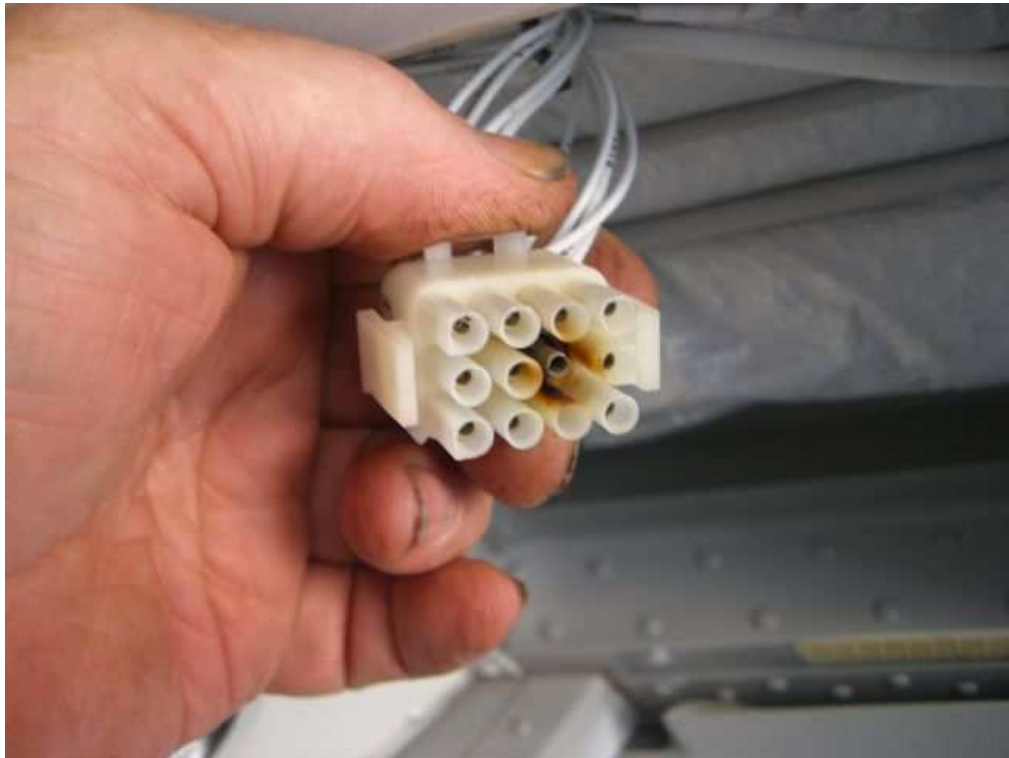
There have been some field reports indicating overheating of the connector plug J104/P104 at pin 8 between the aircraft wiring loom and the overhead electrical panel.

- 1.3. Inspect the connector for signs of burning or charring. Figures 2 and 3 depict damaged connectors.

- 1.4. If no evidence of heat damage is evident then re-install the interior panels using the existing fasteners. Proceed to Section 2 if evidence of heat damage exists.

- 2.2. If possible, remove the contact crimp pin and socket attached to circuits HC1A14 and HC1B14 from connectors J104 and P104. Cut off the crimp contacts. If the crimp contacts associated with circuits HC1A14 and HC1B14 cannot be readily removed, cut the wires as close as possible to the rear of each of the connectors.
- 2.3. Cut a length of 14 AWG wire (M22759/16-14-9) to 12". Using male and female lug terminals insert the 12" length of wire in between circuits HC1A14 and HC1B14 as shown in Figure 4. The connections are to be covered in heat shrink tubing. Refer to the Parts table for terminal part numbers.
