SB-GA8-2014-115

Service Bulletin

Installation of fire-resistant washer and inspection of engine isolator mount orientation

All GA8-TC 320 aircraft up to and including serial no. GA8-TC 320-14-205

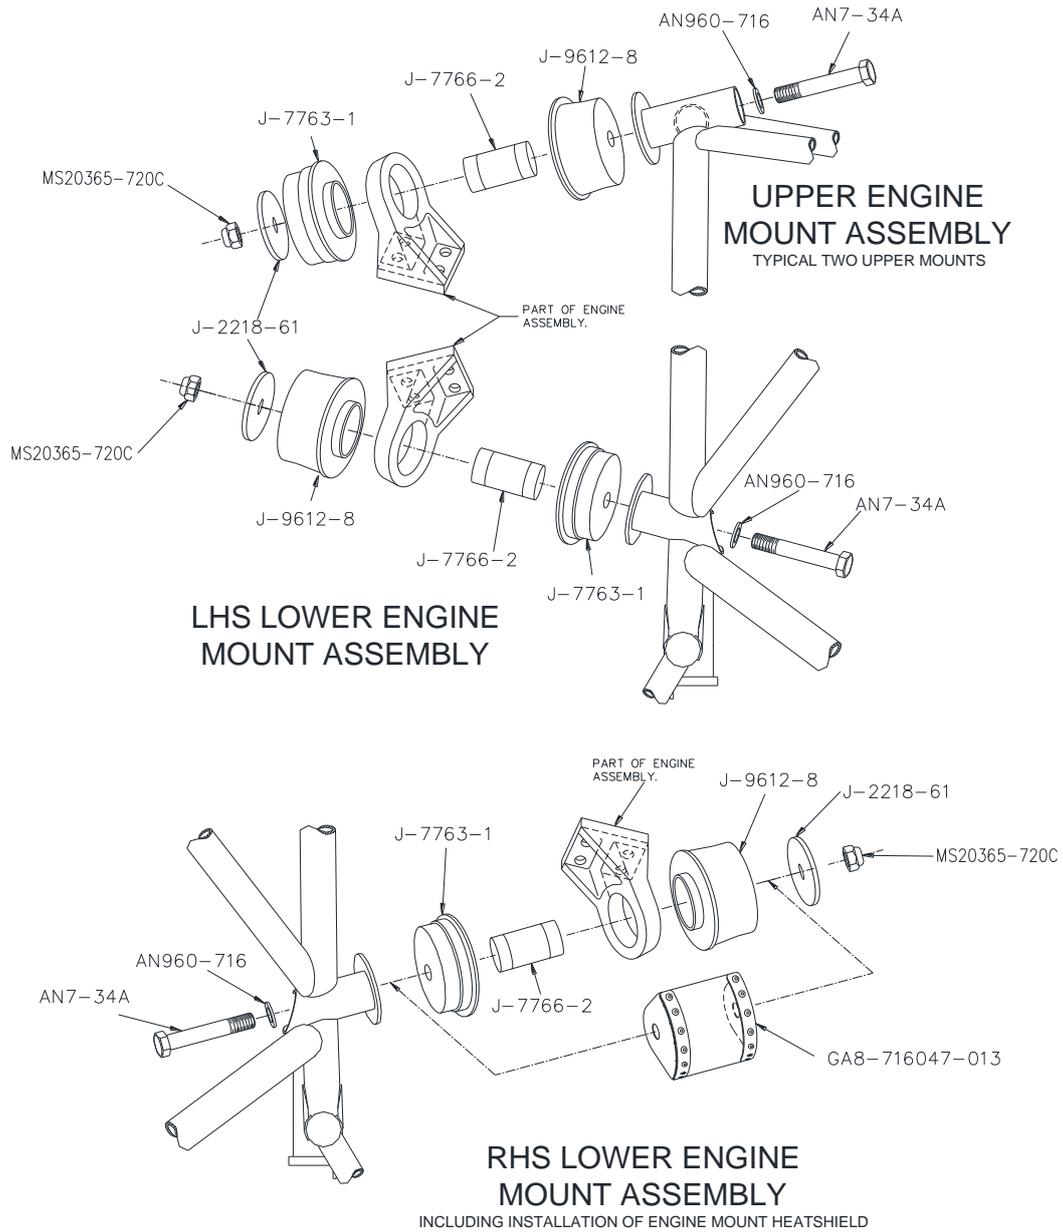
Figure 1: Mount Installation

3. Relieve the weight of the engine from the isolator mounts using an appropriate hoist.
4. Check the orientation of the engine isolator mounts to verify that the mounts have been installed in accordance with Figure 1. Specifically mount part no. J-7763-1 must be positioned on the compression side of the engine lug. For upper mounts this would be on the forward side and for the lower mounts this would be on the aft side of the engine lug. The part number of the mounts can be found moulded into the elastomer on the periphery of the mount. A depiction of the mounts is shown in Figure 2. If any of the isolator mounts are not installed in accordance with Figure 1, proceed to step 5, otherwise skip to step 8

6. Re-install the isolators such that they are oriented in accordance with Figure 1.
7. Inspect the cowls for evidence of damage caused by excessive drooping of the engine. If damage is found, contact GippsAero for further assistance.
8. Regardless of mount serviceability, a J-2218-61 steel washer is to be installed on the forward side of each of the four engine isolator mount locations. The AN7-33A bolt is to be replaced with an AN7-34A bolt, verify correct length upon installation. Depending on bolt grip length the existing AN960-716 washer maybe retained or discarded. Ensure that engine mount retention bolts are torqued to 450-500 in-lb per Chapter 20-10-00 of the Service Manual.

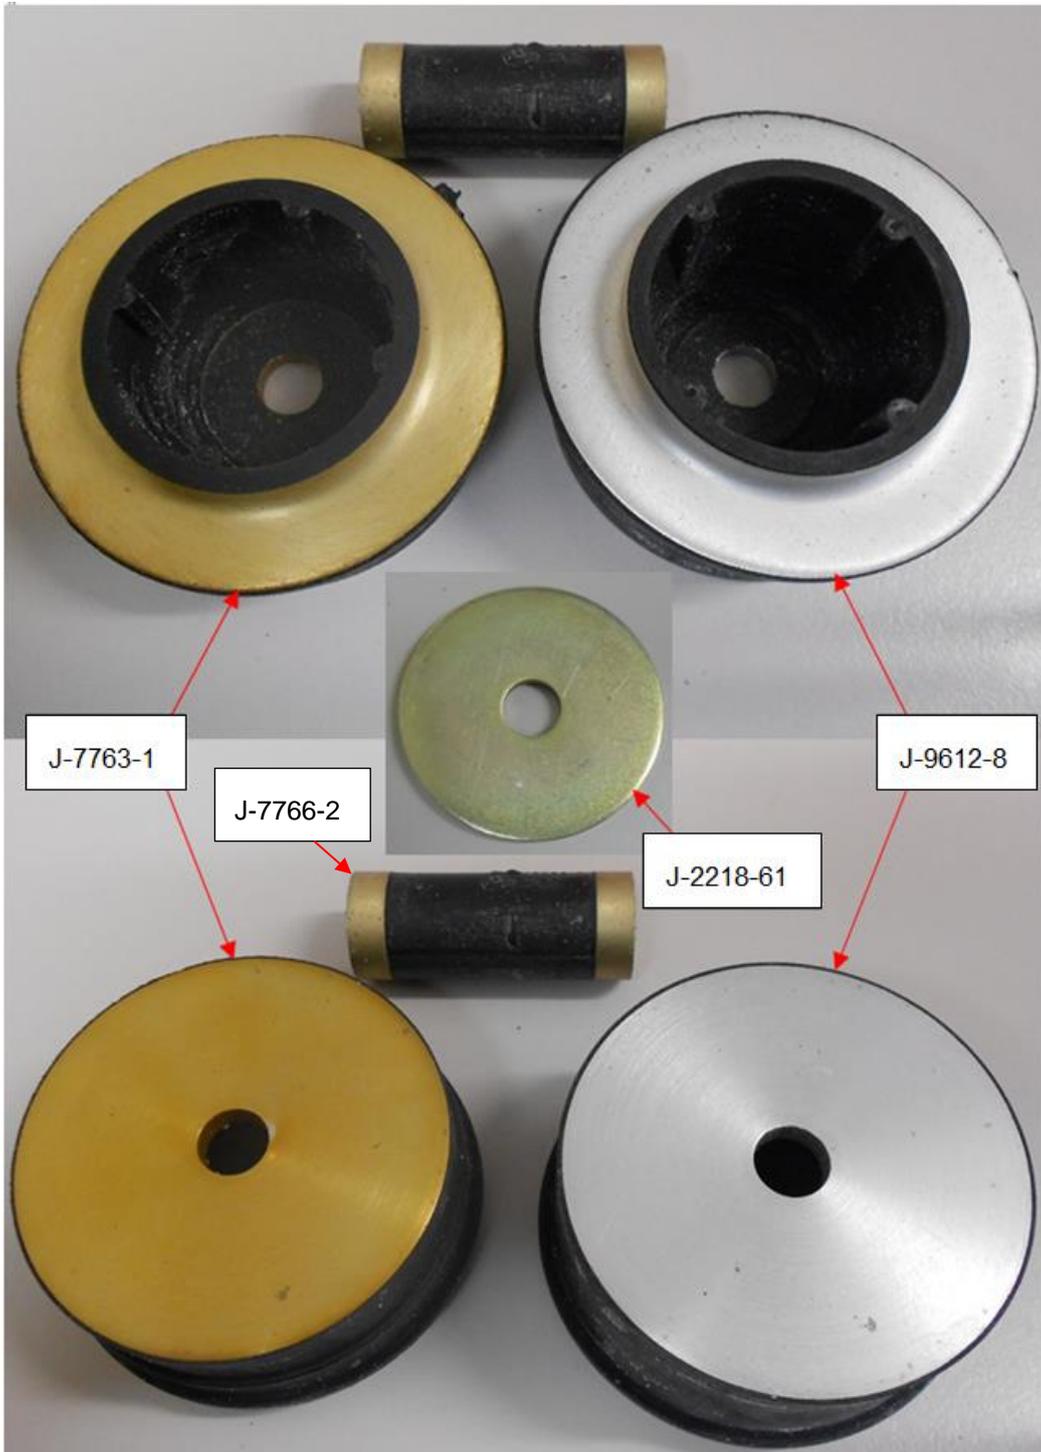
Figure 2: Mount Depiction

1. Remove the engine cowls in accordance with the applicable Service Manual.
2. Verify that the installation of the engine isolator mounts includes a steel washer J-2218-61 (shown in Figure 2 below). Proceed to step 3 if the washers have not been installed, otherwise skip to step 10.
