# Service Letter

Levelling Point Inspection

GA8 serial numbers GA8-00-004 through GA8-08-137.

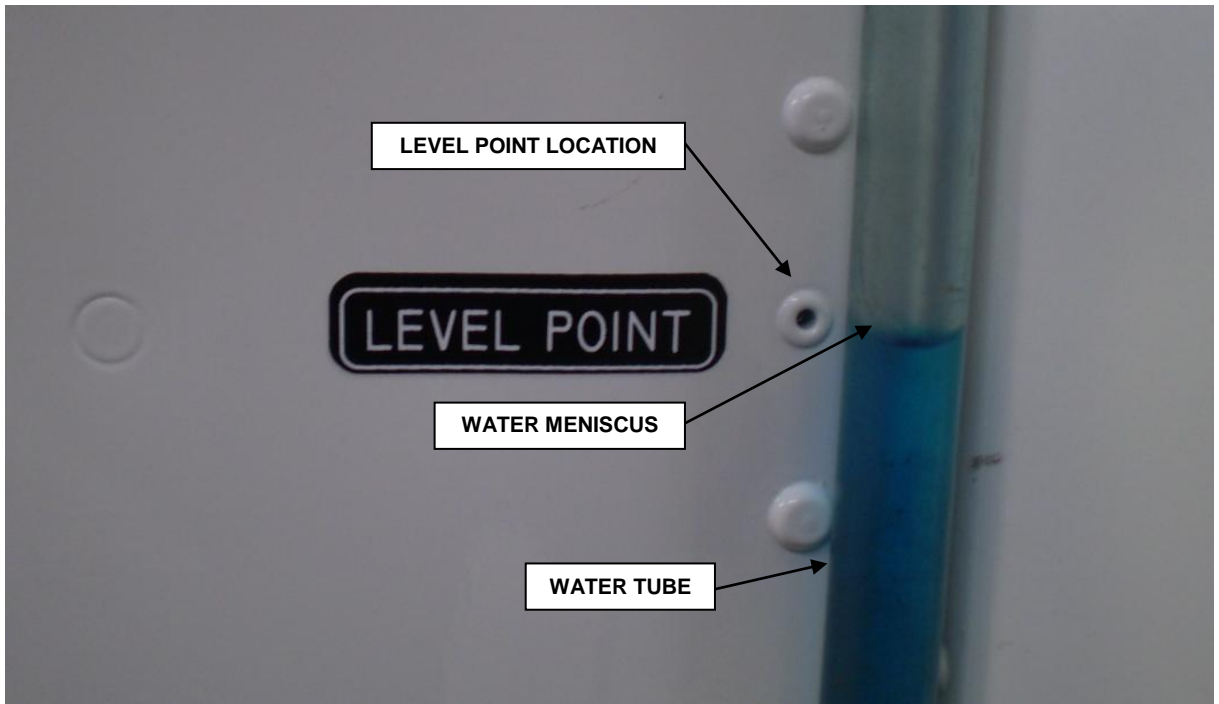
**Figure 1**

4. The person at the forward levelling point is to move the tube up or down the side of the aircraft until the meniscus in the tube is located at the same level as the centre of the forward levelling point, ensuring the tube is close to the levelling point for sighting (refer to Figure 1). The person at the aft end should hold the aft end of the tube steady against the aircraft while the person at the front is moving their end.
