Nomad

SERVICE BULLETIN

STABILISERS — HORIZONTAL STABILISER — MAIN SPAR AND UPPER SKIN — INSPECTION (POST MOD N663 AND N768)

ANMD-55-32

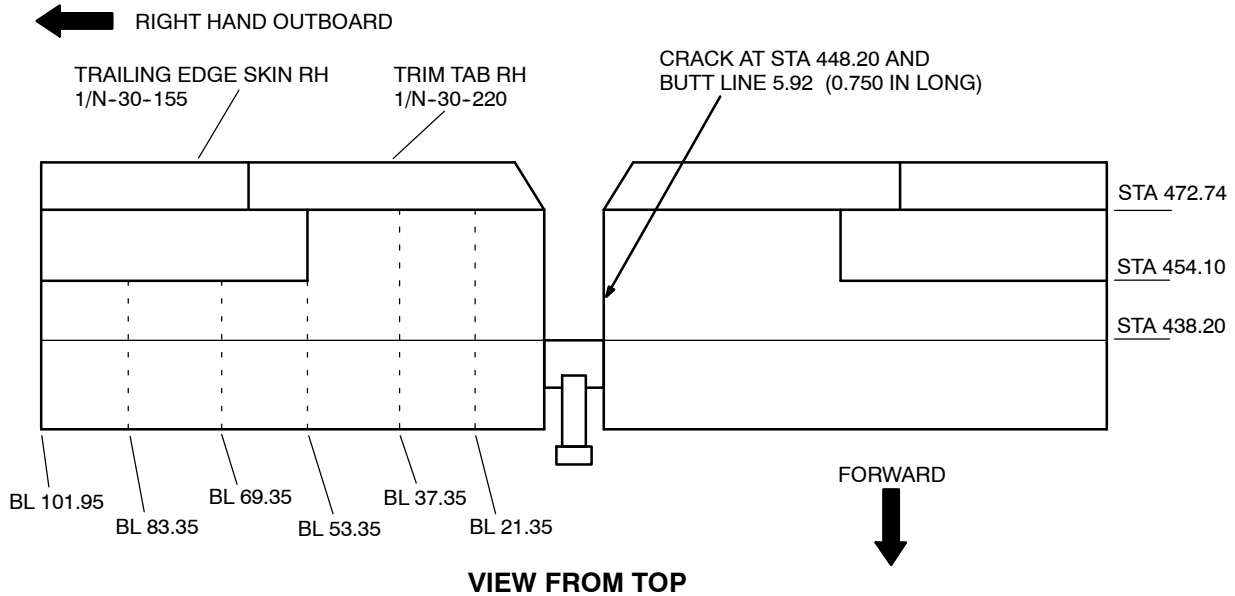
- (1) Remove the dorsal fin (Ref MM Chap 553000).
- (2) Remove the horizontal stabiliser (if required) from the aircraft (Ref MM Chap 552000).
- (3) Visually inspect the inboard ends of upper and lower flanges of the horizontal stabiliser main spar web (Ref figure 1 view A) for fatigue cracks.
- (4) Check assembly of the web flange (bend radii) and edge of the doubler plate PN 1/N30285 shown by figure 1 view C and view D and report its conformance to either of the two views.

- (5) Visually inspect the horizontal stabiliser upper and lower main and leading edge skins as shown in figure 1 view E, for fatigue cracks.
- (6) Visually inspect the horizontal stabiliser upper and lower skin surfaces paying particular attention to those areas indicated in Figure 2.
- (7) Fit the horizontal stabiliser (Ref MM Chap 552000).

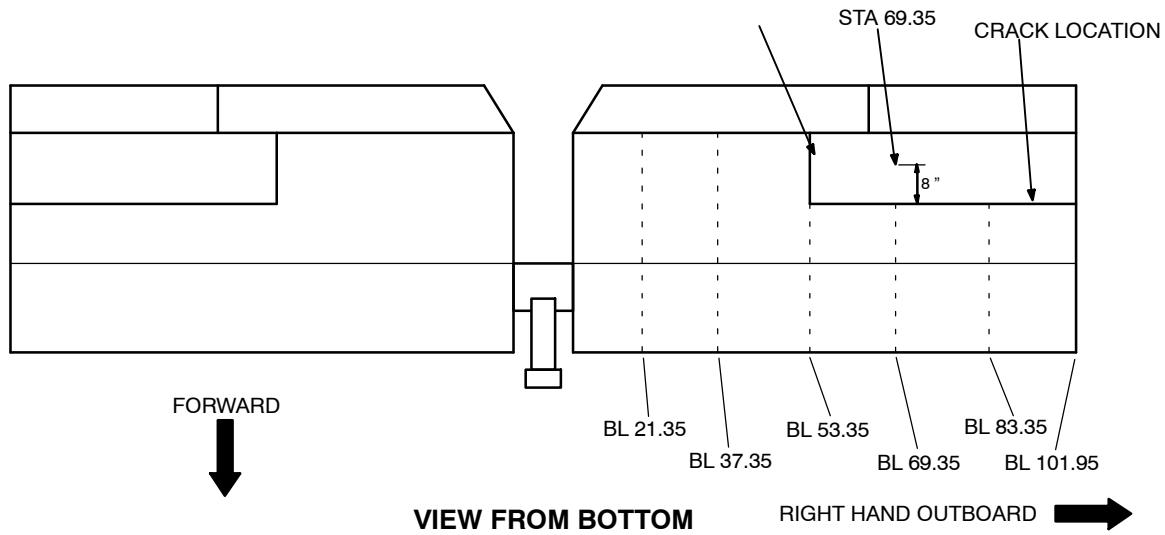
A number of operator Defect Reports have been received which have indicated a problem with cracking on the horizontal stabiliser in areas other than those indicated by Service Bulletin ANMD-55-32 (original). Figure 2 shows the locations of these cracks and investigation by ASTA shows that this cracking is due to normal fatigue and stress loads.
