# FLIGHT CONTROLS - RUDDER PEDALS - BRAKE PUSH ROD - INSPECTION

All Nomad N22 Series and N24 Series aircraft.

An instance has been reported in which failure of the brake push rod end fitting PN 1/N-45-970 has occurred. Further investigation has revealed that excessive depth of the lightning hole in the end fitting caused the rod end fitting to fail. This Service Bulletin has been released to eliminate possible failure of brake push rod end fittings.

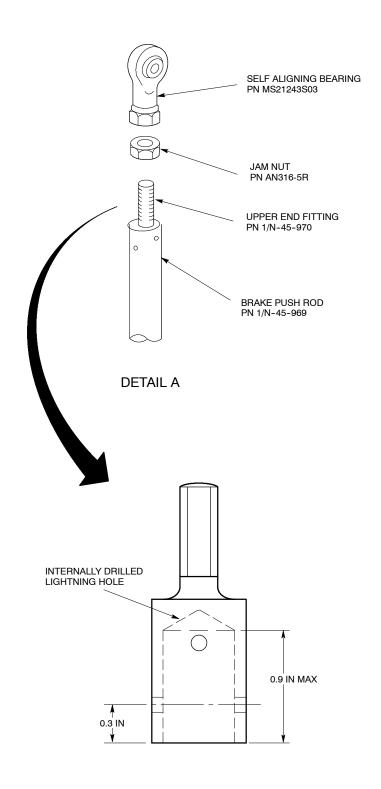
Figure 2 Upper End Fitting — Brake Push Rod

To amend the rod end fitting hole depth specified in Figure 2 and include additional requirements to parts availability.

(1) Measure the depth of the lightning hole in the upper end fitting (Ref Fig 2) using a suitable depth gauge.

- (2) Fit a new upper end fitting PN 1/N-45-970 if the depth exceeds 0.9 in as shown in Fig 2.
  - (3) If the upper end fitting is to be renewed proceed to 2.D. otherwise continue.

- (1) Discard the old end fitting.
- (2) On the new end fitting, mark the centre of the lower taper pin hole 0.3 in from the lower end as shown in Fig 2.
- (3) Using No 30 (0.1285 in) drill in a drill press pilot drill the lower taper pin hole through both sides of the new end fitting.
