SB-GA8-2013-99

Issue 3

Service Bulletin

Inspection and modification of Strut Pick-up ribs – Rib no. 5 and Rib no. 6

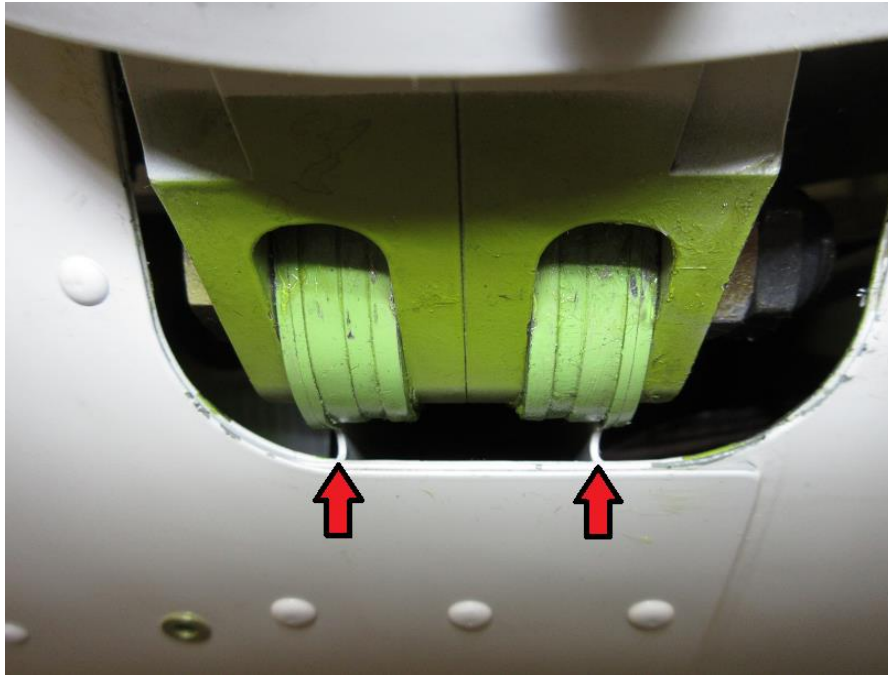
Figure 1: Strut Pickup Rib Inspection Area

- 4) Perform a detailed visual inspection, using at least a strong light source and preferably 10x magnification, or a non-destructive inspection, of the radius below the wing strut attachment lug(s) as identified in Figure 1, Figure 2 and Figure 3. Check for any crack indications. Typical cracks are shown in Figure 4.
- 5) If any cracks are detected in the Ribs, determine an approximate crack length and proceed to Part 2; otherwise continue to Step 6.
- 6) If no cracks are detected in the Ribs, then slide LHS and RHS Strut to Fuselage Fairings against the fuselage and fasten using removed fasteners. Inspection is complete.

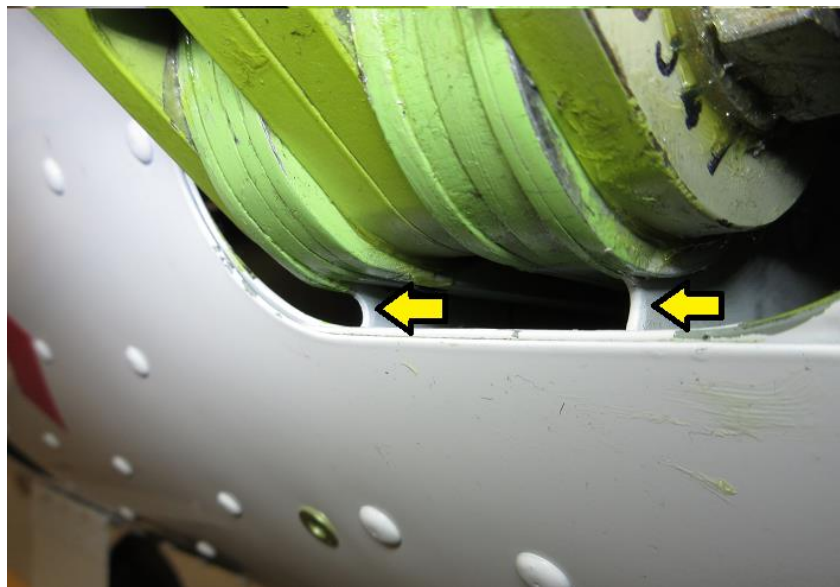
Figure 2: Possible Crack Locations

Operators have previously reported that fuselage floor Ribs #5 and #6 develop cracks in service. Metallurgical examination of affected Ribs indicates these cracks are ductile overload failures. Upon receipt of these reports, GippsAero published Service Bulletin (SB) SB-GA8-2013-99, Issue 1. The SB provided instructions to blend away a notch feature under the fuselage to wing strut attachment lug on Rib #5 and Rib #6.

After accomplishing the SB, some operators reported that cracking was subsequently discovered adjacent to the blended area. In response, GippsAero is publishing this Issue 3 of SB-GA8-2013-99.

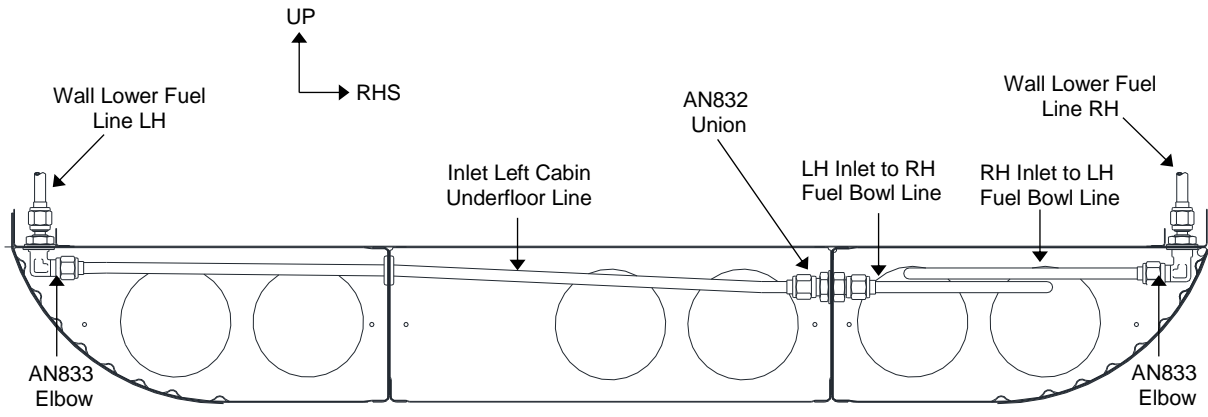
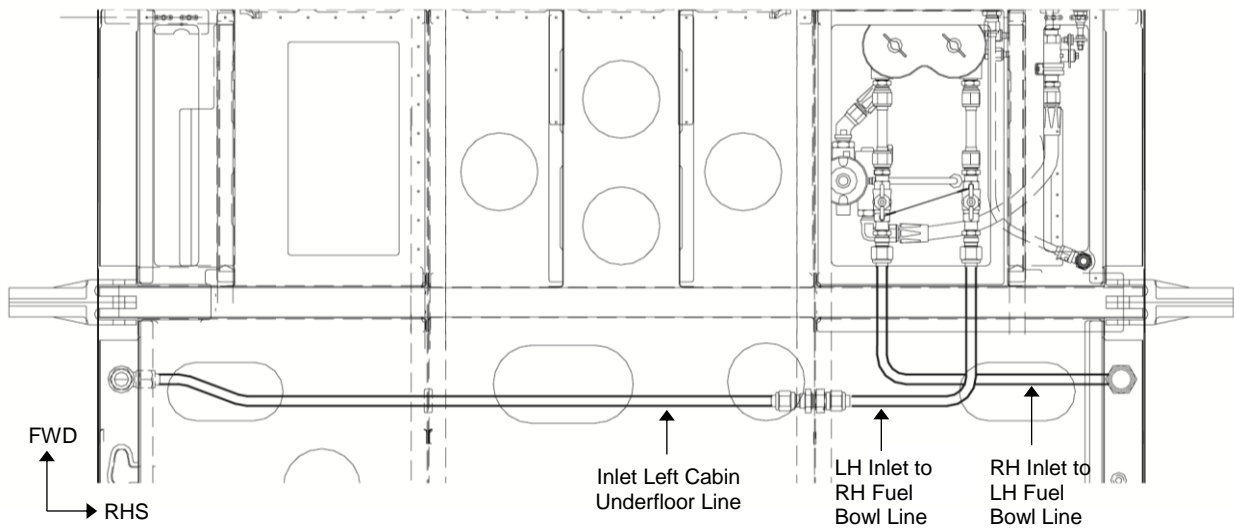
Figure 14: Fuel Lines - view looking forward toward Rib #6. (Mk II Fuel system shown, Mk I similar)

Figure 15: Fuel Lines - view looking from above (MK II Fuel system shown, MK I similar)

- 9) Disconnect and remove the AN924 Nut and AN832 union at the RH keel beam penetration (See Figures 14 and 15).
- 10) Slide the Inlet Left Cabin Underfloor Line (GA8-282013-109) through the Keel Beam penetration to the RH side as required to ensure clear access to the lower web of Rib #6 LH.
