MANDATORY

Service Bulletin

Cargo Door Forward Slide, operating rod and handle.

SB-GA8-2005-23
Issue 5

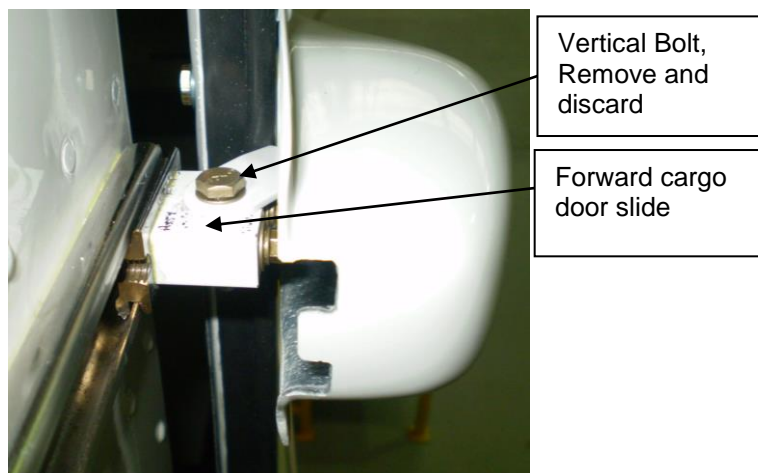
Figure 1: Forward Cargo Door Slide with door swung open.

1. Open the door handle so that the door swings out to gain access to the Forward Cargo Door Slide Assembly, see Figure 1 below.

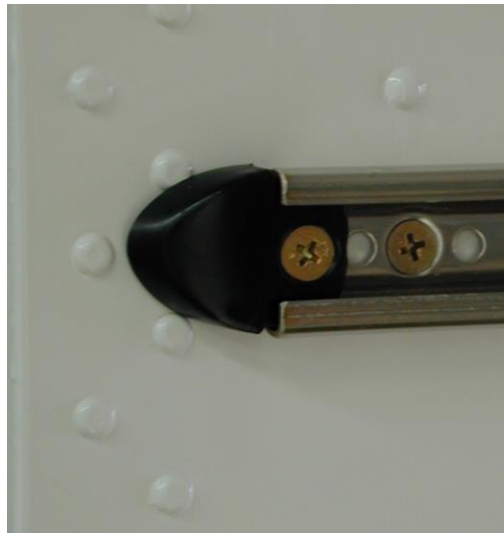
Figure 2: Nylon Track End

2. Remove the Forward Cargo Door Slide, by removing the vertical bolt and sliding the slider out of the track. On earlier versions of the Airvan it would be necessary to remove the Nylon Track End as shown in Figure 2 below to be able to remove the slider.

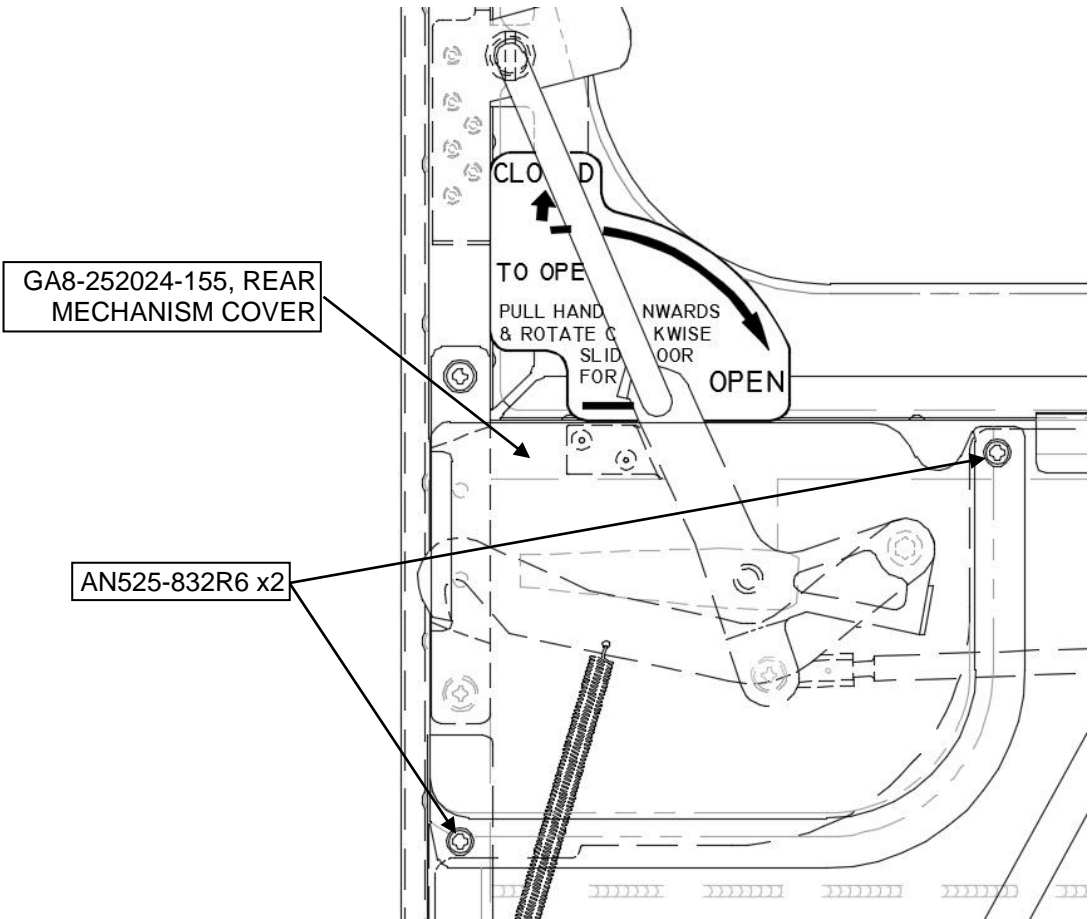
Figure 7: Rear Mechanism Cover

1. Remove Rear Mechanism Cover, refer to Figure 7.
2. Inspect threaded stud at the end of the operating rod, refer to Figure 8. If there is any indication of bending then either replace the operating rod with Item 9 from Table 3 or locally modified rod detailed in Part B2 using the following steps.
3. Disconnect the rod ends from the handle and pivot arm. Remove the forward rod end and pull out the operating rod.
4. Install the operating rod through frame bush prior to installing forward Rod End. Install rod ends and connect to the handle and pivot arm.

5. With the door handle held fully open / against the stop, check that the operating rod does not hard foul against the rear door handle pivot post, refer to Figure 9. If required rework the rear door handle pivot post.
6. Reinstall the Rear Mechanism Cover, refer to Figure 7.
