SB-GA8-2014-117

Service Bulletin

Installation of Crew Seat adjuster straps.

All GA8 & GA8-TC 320 Aircraft

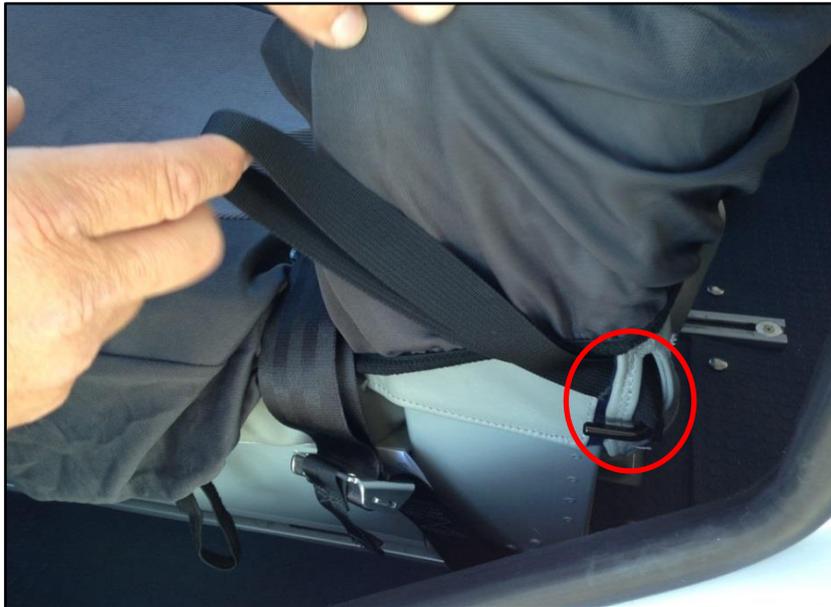
Figure 1: Strap Installation

1. Gain clear access to the seat adjuster pins by adjusting the crew seat to the forward most position.
2. Pass the pin through the smaller opening on the strap and slide the strap around the bend.
3. Separate the seat covering around the pin to permit passing the strap in between the seat covering as shown in Figure 1 below.

4. Secure the seat covering back in position by attaching the hook and loop sections of the Velcro around the strap.

Ensure that the strap has been securely installed. Verify that the strap will not inadvertently slide out when pulled.

5. Repeat steps 2 to 4 for the opposite side adjuster pin.
6. Test the installation of straps by pulling both straps of the seat upwards at the same time to adjust its position. Verify that the straps do not interfere with the operation of the seat belts including snagging of the seat belts. Verify that the seat adjuster pins fully seat into the track upon retraction.
7. Optionally, repeat steps 1 to 6 for the other crew seat in the aircraft if installed.
